IBP-Report HTB-12/2007

Durability Assessment of Glass Fibre Insulation in Flat Roof Constructions

for
Saint-Gobain Isover

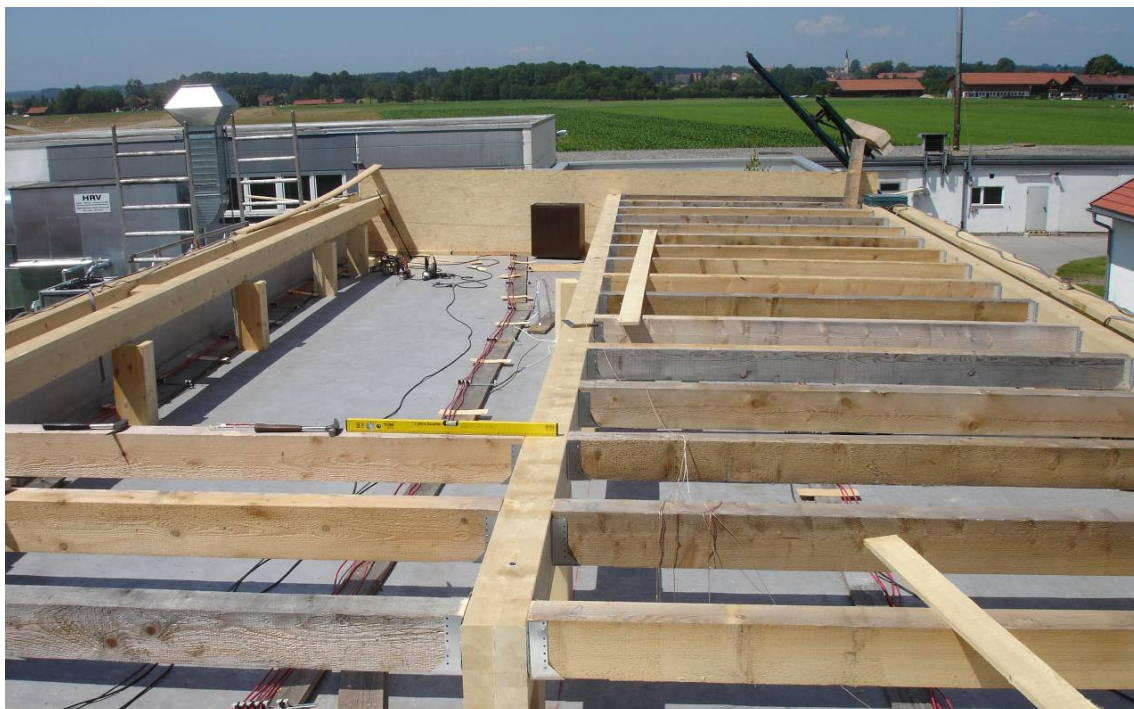
Figure 4: Installation of electrical wire heating and preparation of the load bearing roof structure above the attic space.

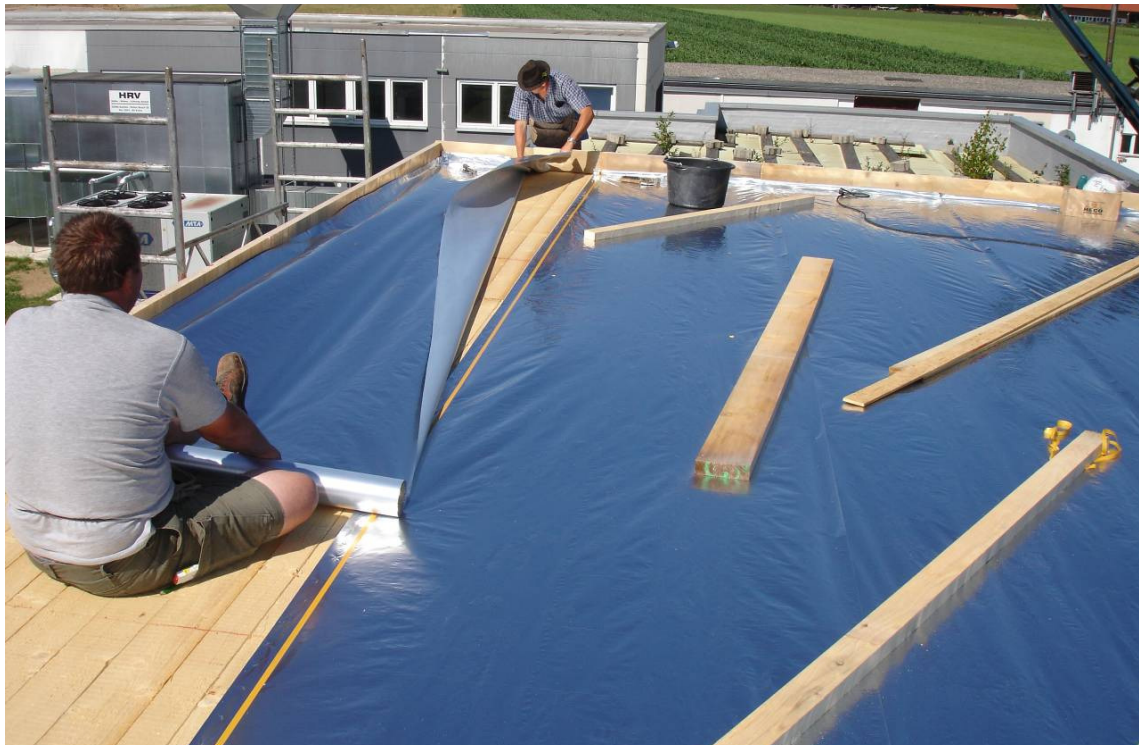
Figure 5: Airtight application of the aluminium vapour barrier on the wooden sheathing over the attic space.

In August 2006 the roof sections with different insulation thickness (90 mm and 175 mm) were set up on the field test site of the Fraunhofer Institute for Building Physics (IBP) in Holzkirchen. Figure 3 displays the IBP field test site with location and orientation of the selected test building. The flat roof sections cover an area of 6.5 m x 6.3 m (approx. 40 m²) each. The test building itself is heated in winter time. This is, however, not sufficient to control the temperature in the attic space under the roof. Therefore, the attic temperature is controlled by electrical wire heating which can be seen beneath the rafters in Figure 4. The rafters are covered by 24 mm strong wooden sheathing boards on which the aluminium vapour barrier is installed (Figure 5).

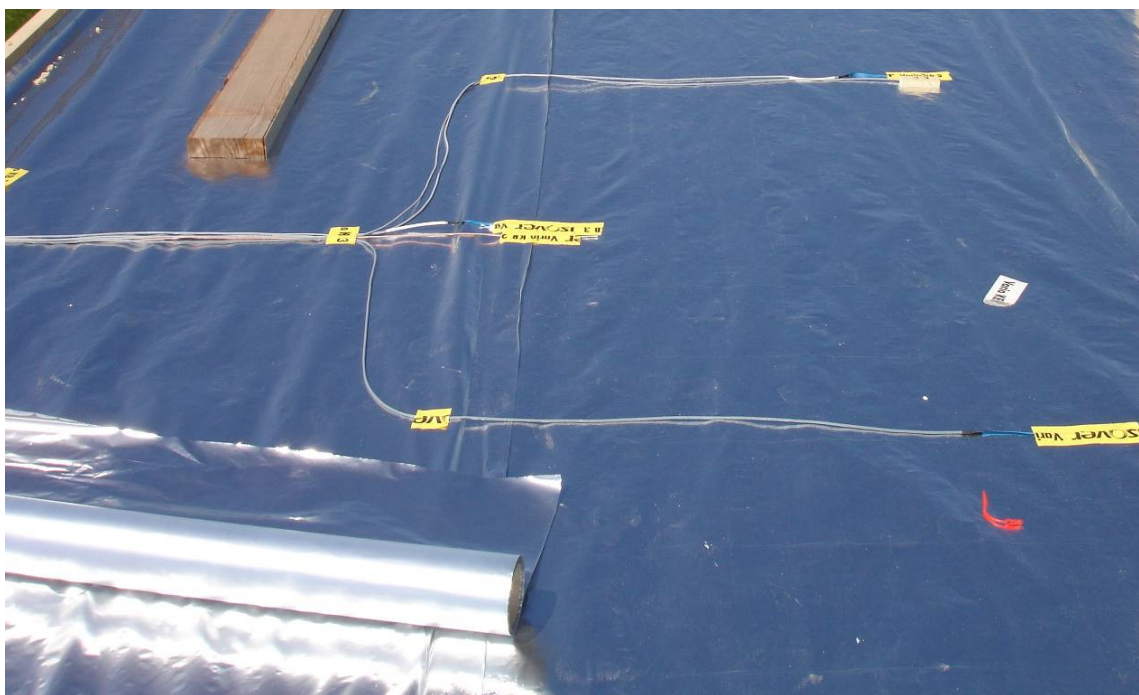
Figure 6: Installation of the interior sensors (below the glass fibre boards) for RH and temperature measurement. In the middle, a PT100 is combined with a capacitive RH sensor. Additional PT100 sensors, one combined with a wood moisture sensor, can be seen at the top and bottom of the photograph.

Before the glass fibre boards can be laid the measuring equipment had to be installed. The interior temperature and humidity sensors are glued directly to the vapour barrier (Figure 6). In the centre of the roof sections the capacitive RH sensor is placed together with a PT100 temperature sensor. At a diagonal distance of approximately 2 m in both directions, two further PT100 are installed one combined with a piece of wood containing moisture pins. The readings of the moisture pins (measurement of electrical resistance) which serve only as back-up for the capacitive sensors will be taken at weekly intervals.

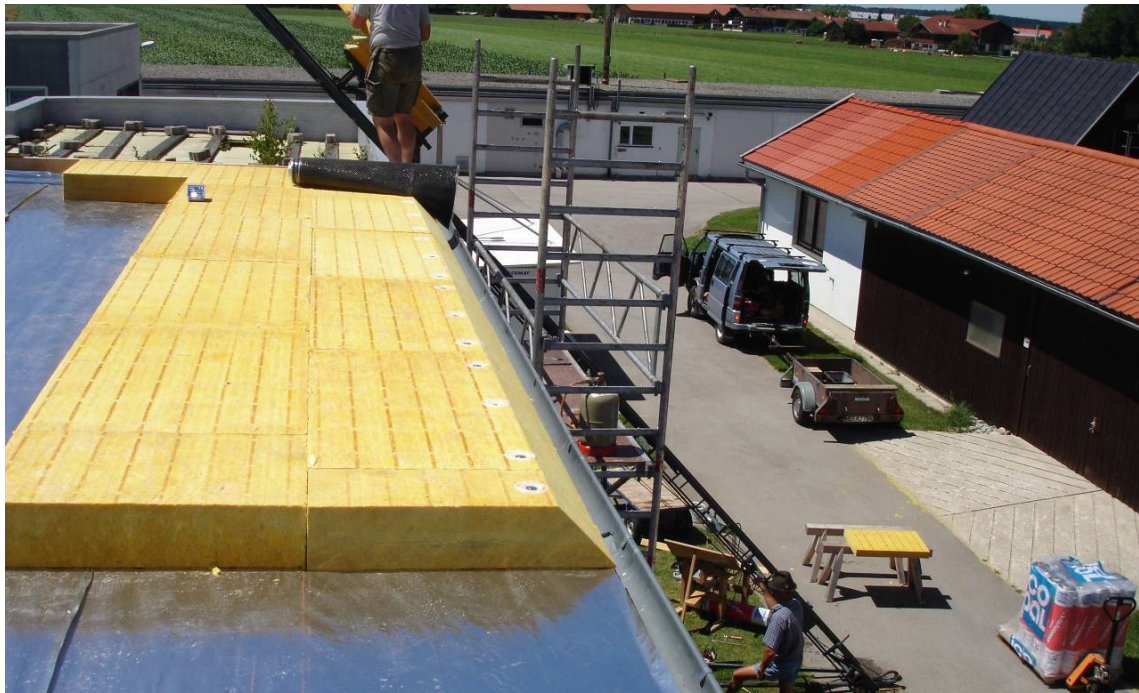
Figure 7: Laying of the wet insulation boards on the vapour barrier.

The installation of the insulation layer on top of the continuous vapour barrier is shown in Figure 7. While laying the glass fibre boards the sensors measuring the hygrothermal conditions in the "middle" of the insulation layer are placed sideward in a small cavity of the centre board (Figure 8). Because more severe conditions were expected towards the top of the insulation layer, the vertical sensor position is not exactly in the middle but located about one third of the board's thickness from the top. However, for reasons of simplicity this position will be labelled as "middle" in the following descriptions. Finally, the last sensors are installed on top of the glass fibre boards just below the roofing felt. Figure 9 shows a photograph of the sensors located at the exterior surface of the insulation layer. A closer look at the capacitive humidity sensor with its protecting metal tube located next to the central PT100 sensor is presented in Figure 10. The installation of the back-up moisture sensor (a piece of wood equipped with moisture pins) located next to another PT100 fixed to the surface by adhesive tape is shown in Figure 11.

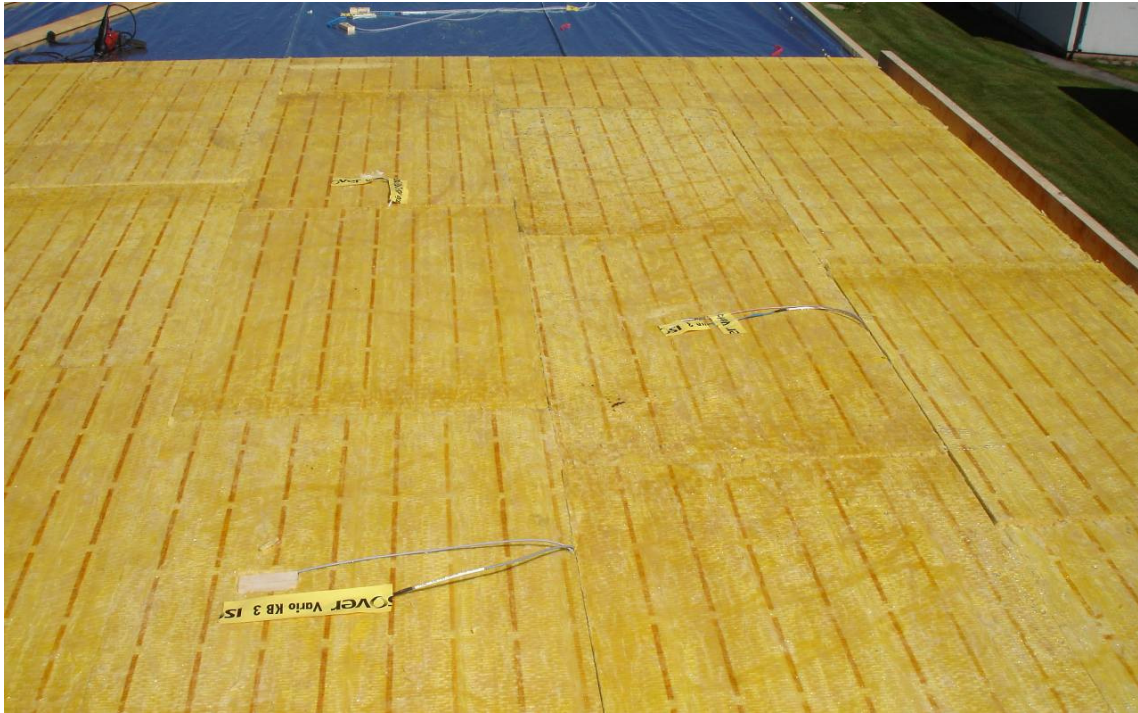
Figure 9: Installation of the exterior sensors (on top of the insulation layer) for RH and temperature measurement.

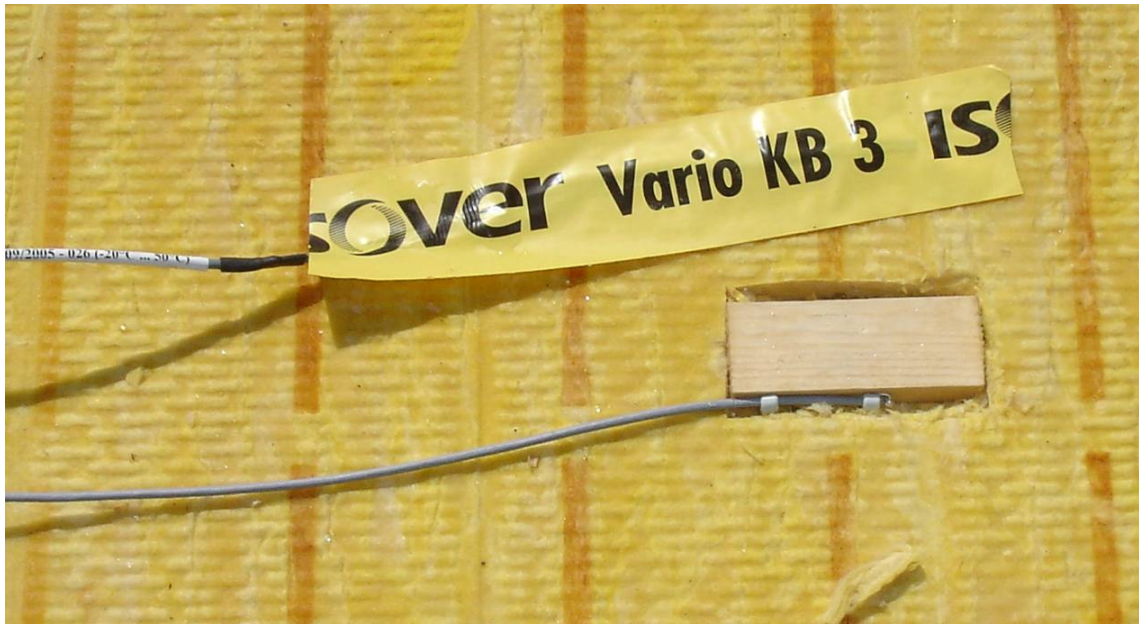
Figure 11: Close look at the wooden cubes with electrical resistance moisture sensors next to a PT100 on top of the insulation layer.

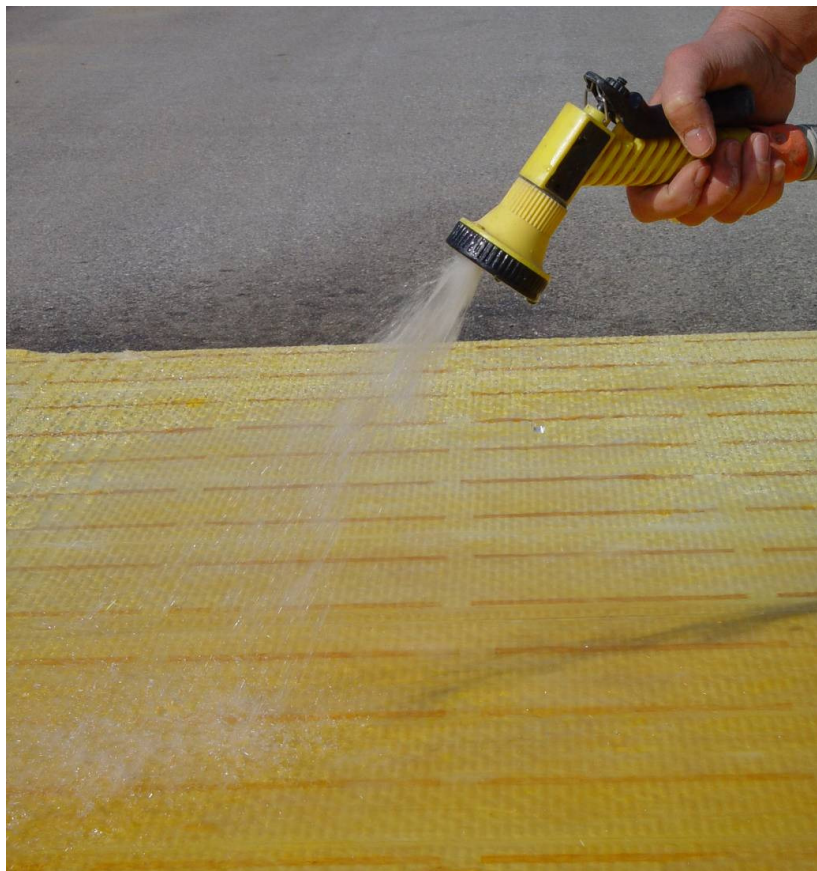
Figure 12: Spray-wetting of the glass fibre boards before installation.

To raise the initial water content of the insulation layer prior to installation (planned were approx. 2 kg/m²) the glass fibre boards are intermittently subjected to spray-wetting with a garden hose for several hours (Figure 12). The moisture uptake is registered by weighing representative boards before and after this treatment. However, the target moisture is not always attained due to the hydrophobicity of the boards. Another problem is the warm weather during the roof set-up which tends to dry out the boards. Therefore, just before closing the roof with the bituminous felt (the boards are wetted again by using a watering can. In order to prevent any drying of the initial moisture through joints or section interfaces the roofing felt was glued to the vapour barrier at the edges (Figure 13).

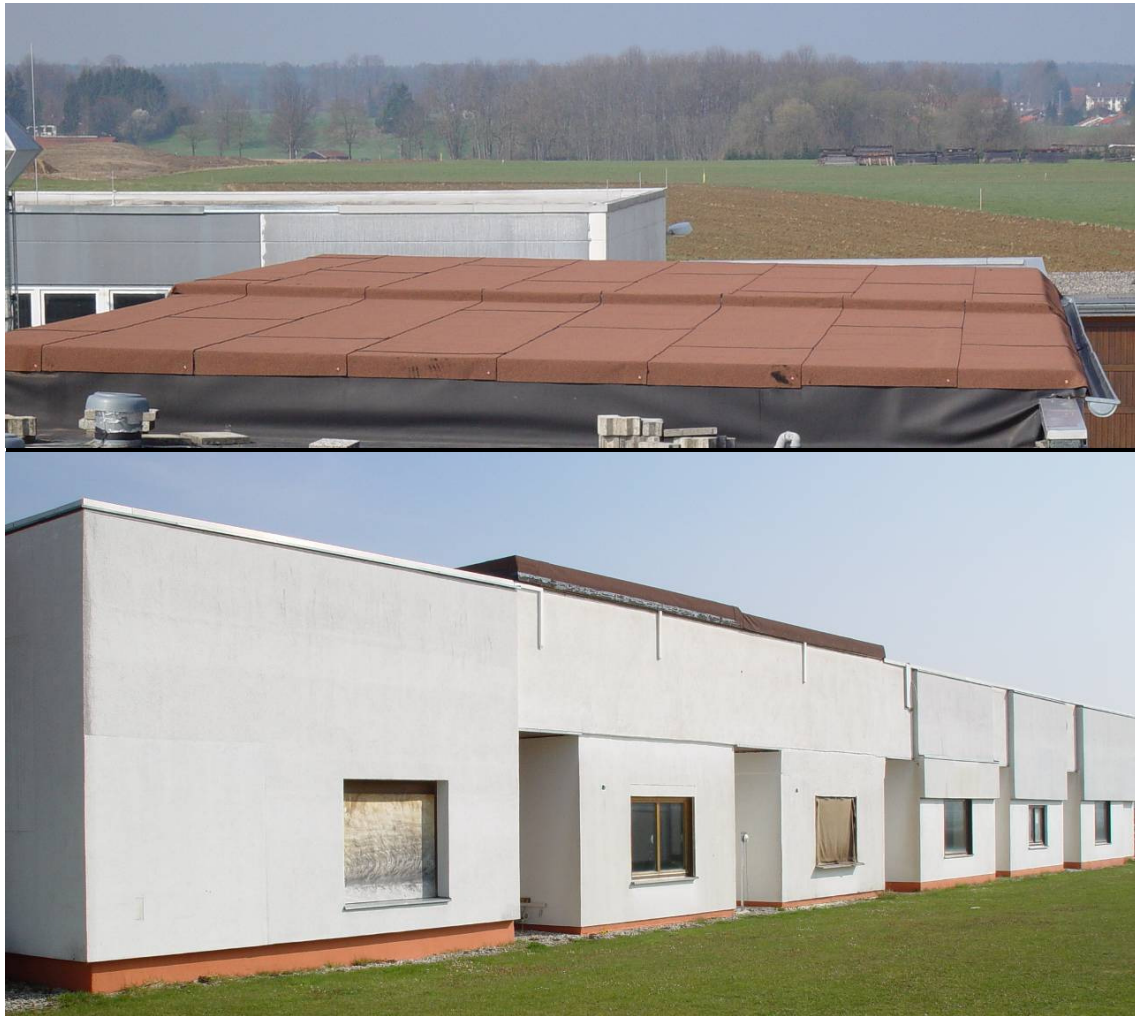
Figure 14: View of the finished flat roof sections from the top and from the south side of the test building.

As soon as the roof construction works are completed the continuous recording of the data delivered by the installed sensors begins. Figure 14 shows a top view of the completed roof and a photograph from the south façade of the

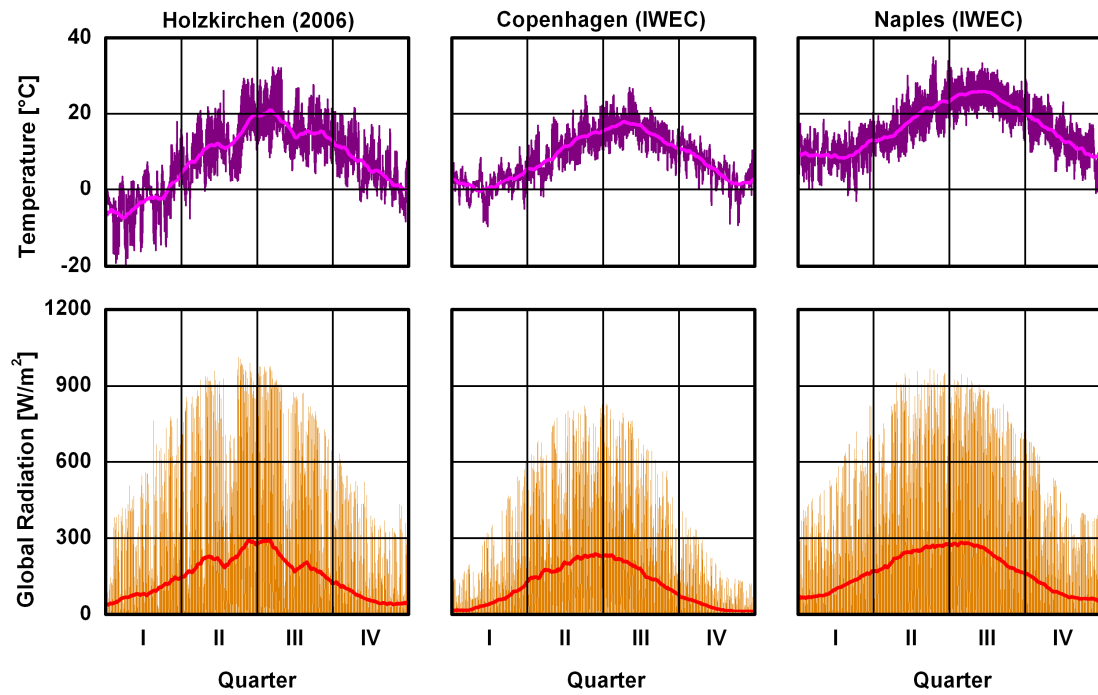
Figure 17: Outdoor air temperature (top) and solar radiation (bottom) of Holzkirchen, Copenhagen and Naples displayed as hourly fluctuation and running monthly average.

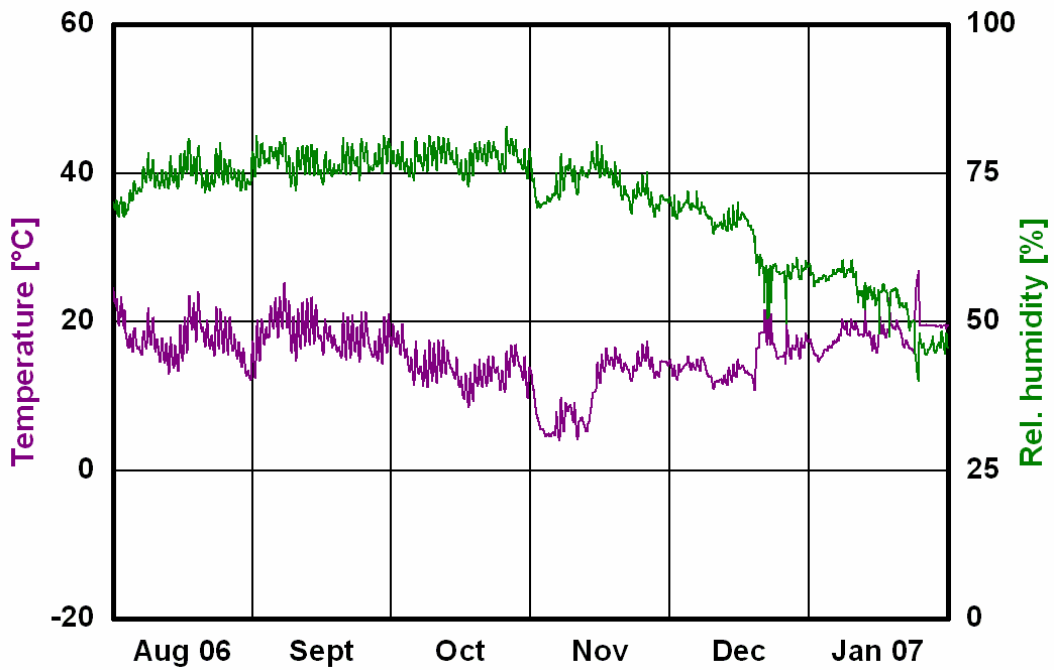
Figure 19: Indoor climate in the attic space during the investigation period.

were only a few days with temperatures below $-5\text{ }^{\circ}\text{C}$ while in a normal cold winter the temperatures can drop to $-20\text{ }^{\circ}\text{C}$ at times. The temperature and relative humidity in the attic space during the observed period is shown in Figure 19. The temperature drop below $10\text{ }^{\circ}\text{C}$ in the first two weeks of November is caused by a failure of the space heating system.

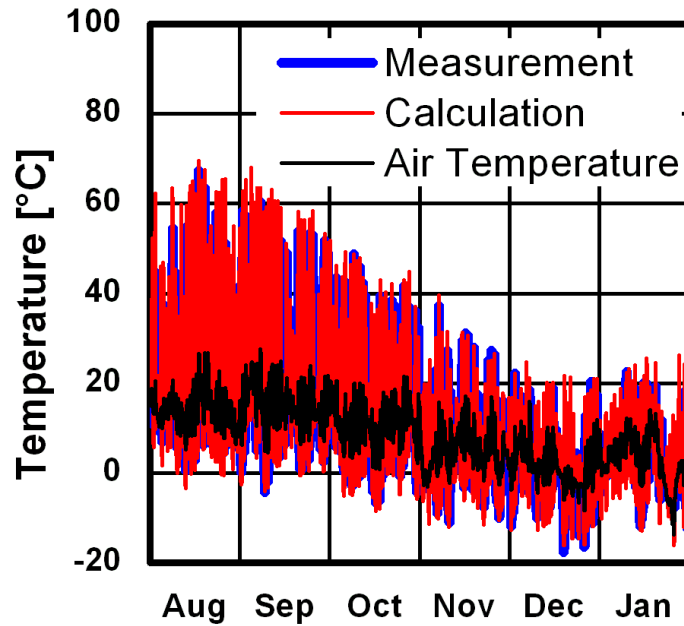
Figure 23: Comparison of measured and calculated exterior temperature variations (position beneath the roofing membrane) in the roof with 175 mm insulation under the indoor and outdoor climate conditions recorded during the test in Holzkirchen.

The surface temperatures for the roof with 175 mm insulation are shown in Figure 23. Again, the agreement between field test and simulation is very good as already observed by analyzing the roof with 90 mm insulation. This proves that the convective heat transfer coefficient ($h_{c,o} = 10 \text{ W/m}^2\text{K}$) as well as the short wave absorptivity ($a_s = 0,66$) and the long wave emissivity ($\epsilon = 0,9$) of the roofing membrane, which are part of the boundary conditions for the simulation, were specified correctly.

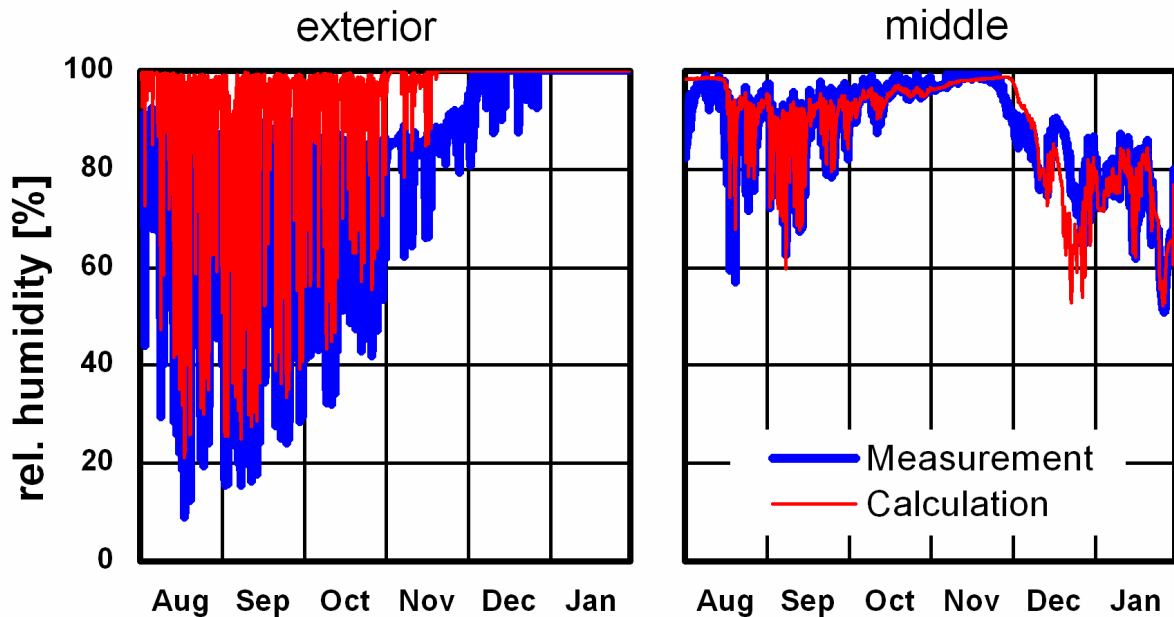
Figure 24: Comparison of measured and calculated relative humidity variations at the exterior sensor position and in the "middle" (60 mm beneath roofing membrane) of the roof with 175 mm insulation under the indoor and outdoor climate conditions recorded during the test in Holzkirchen.

The resulting RH in the roof with 175 mm insulation is plotted for the exterior and the middle sensor position in Figure 24. The interior sensor shows a constant RH of 100 % over the whole experimental period. However, the moisture pins in the small wood sample sensors which were installed for crosschecking (Figure 11), show a fast decreasing water content around the beginning of December (Figure 25). Therefore it must be assumed that the capacitive humidity sensor has become defect. This may be caused by being in contact with liquid water for a few months. Since it is unlikely that this sensor can be recovered there will be no reliable experimental data for the humidity at the bottom of the 175 mm thick insulation layer.

While there is a very good match between calculated and measured RH in the middle of the insulation layer, the simulated RH at the exterior sensor position tends to be higher than the measured RH especially during the night. This becomes even more evident in Figure 26. During the selected late summer period the RH of the simulation goes up to 100 % every night when the roof surface temperature drops down to almost 0 °C. The measured RH, however, only reaches about 90 % and remains flat at that point. This sudden halt at 90 % RH after a steep increase seems unrealistic und indicates either a sensor problem (unlikely considering its performance later on) or a local temperature inhomogeneity.

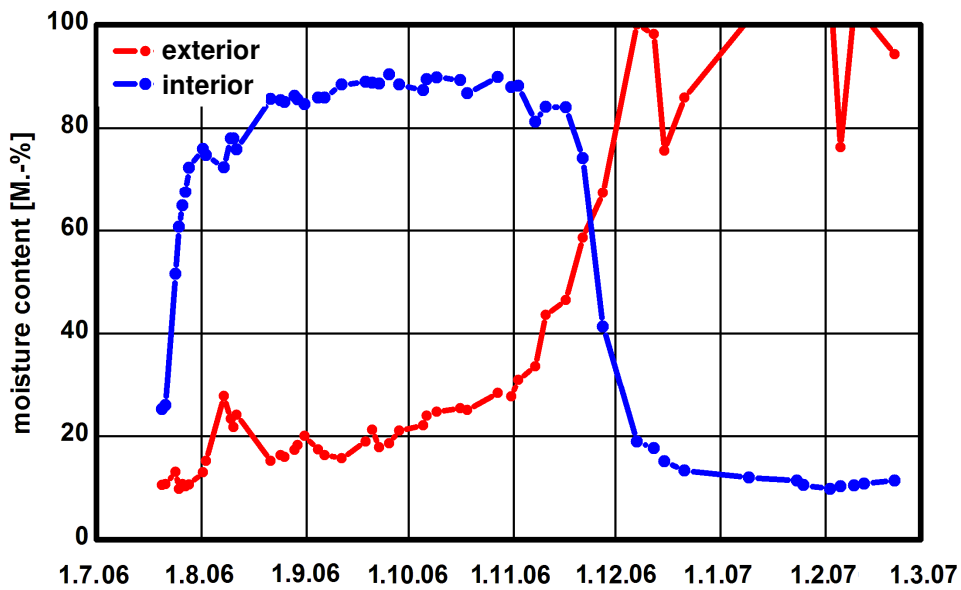
Figure 25: Temporal variation of the moisture content of small wood samples at the top and bottom of the 175 mm thick glass fibre boards measured with moisture pins about twice a week.

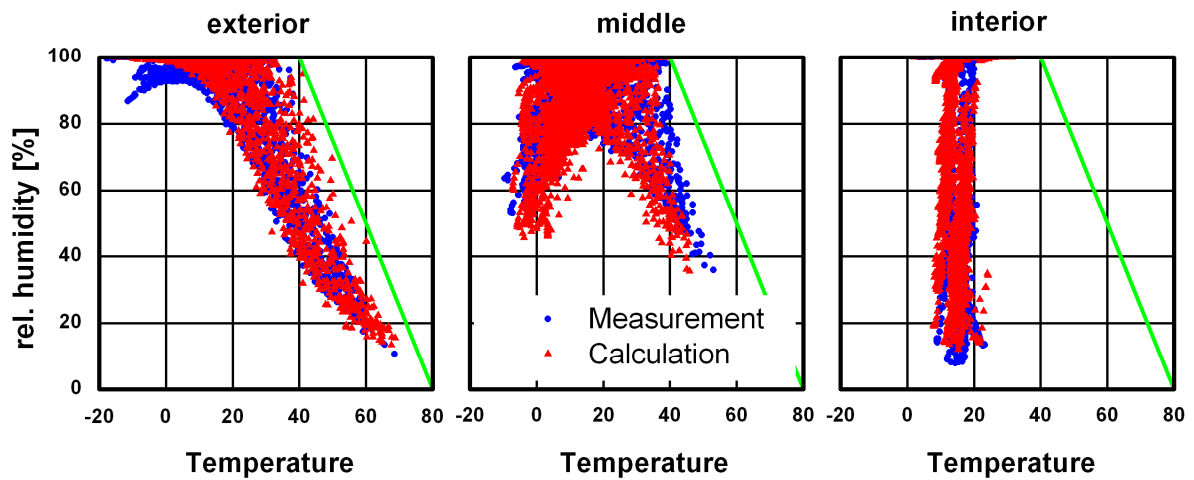
Figure 27: Coinciding temperature and humidity conditions on an hourly basis measured and calculated at three sensor positions in the roof with 90 mm insulation. The green line represents the limiting curve for the hygrothermal conditions determined for the climate conditions in Holzkirchen.

Laboratory tests have shown that the coincidence of high temperature and high humidity has a significant degradation effect on glass fibre insulation. Under dry conditions, a high temperature doesn't do any harm and a high relative humidity is not a great problem as long as the temperature remains low. Therefore, the measured and calculated hygrothermal conditions in the roof are displayed in a special graph where temperature and humidity are plotted against each other for time intervals of one hour. Such a graph is shown in Figure 27 for the three sensor positions in the roof with 90 mm thick insulation.

As expected from the rather well matching temporal variations the agreement between measured and simulated results of coinciding conditions is quite good for all three positions. The highest temperatures with more than above 60 °C (maximum 70 °C) occur at the exterior position beneath the roofing membrane. However, the coinciding RH values remain very low, between 10 % and 30 %. The maximum RH of 100 % is frequently reached at all sensor positions. While the coinciding temperatures stay around 20 °C at the bottom of the roof (interior position) they can reach a maximum of nearly 40 °C in the middle and upper parts of the roof. The limit curve that will not be exceeded at any position in the insulation layer of the investigated roof can be drawn as a straight green line from 40 °C / 100 % RH to 80 °C / 0 % RH (Figure 27)

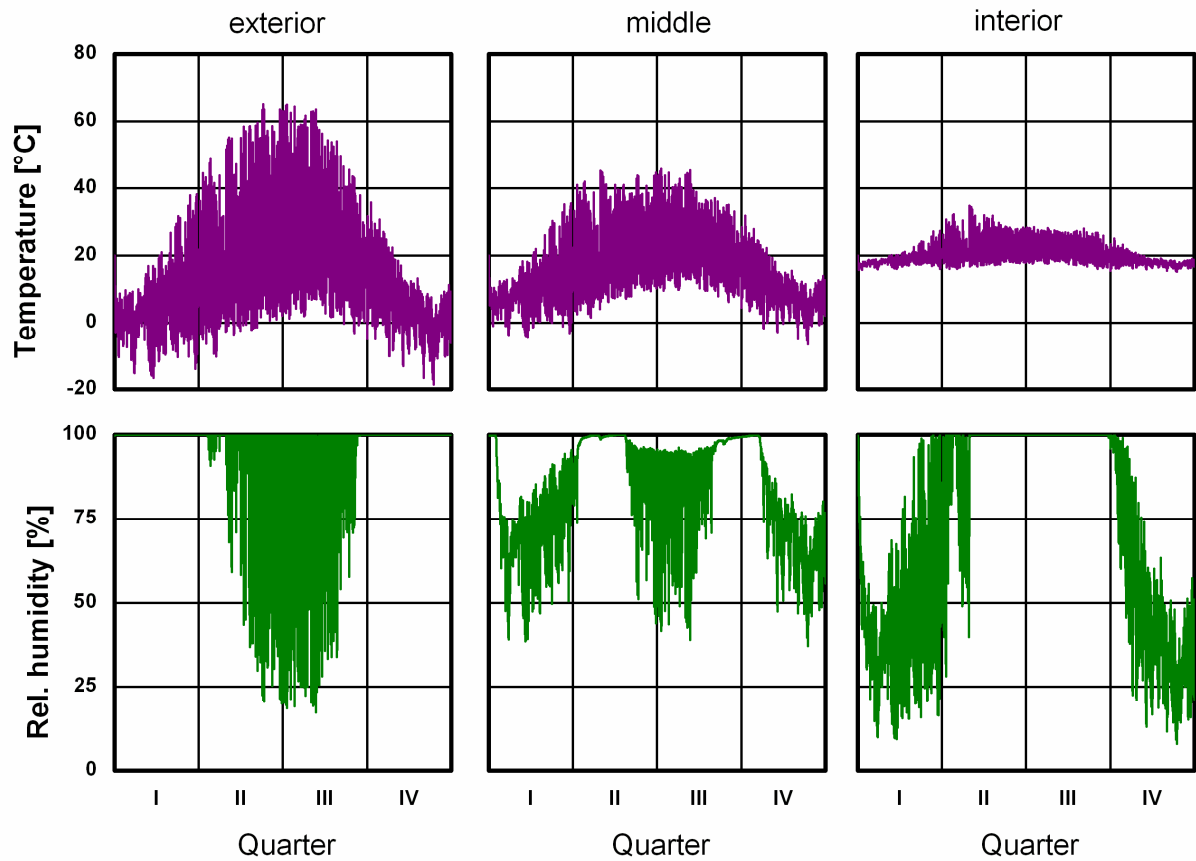
Figure 29: Calculated temperature and humidity conditions at different positions within a flat roof with 90 mm glass fibre insulation in Copenhagen.

The outdoor air temperature in Copenhagen varies between ca. $-10\text{ }^{\circ}\text{C}$ in Winter and $20\text{ }^{\circ}\text{C}$ in summer. The hygrothermal conditions in the insulation layer at the tree monitor positions are shown in Figure 29. The temperature on the exterior monitor shows values between $-15\text{ }^{\circ}\text{C}$ and $65\text{ }^{\circ}\text{C}$. The temporal variations of the relative humidity at the different positions resemble the results obtained for Holzkirchen (Figure 21). The plot of the hourly RH plotted over temperature is displayed in Figure 30. Again, the results are very similar to the data of the flat roof in Holzkirchen (compare with Figure 27). However, the Copenhagen results for the exterior position come a bit closer to the limit curve (green line) and go even slightly over the limit a couple of times.

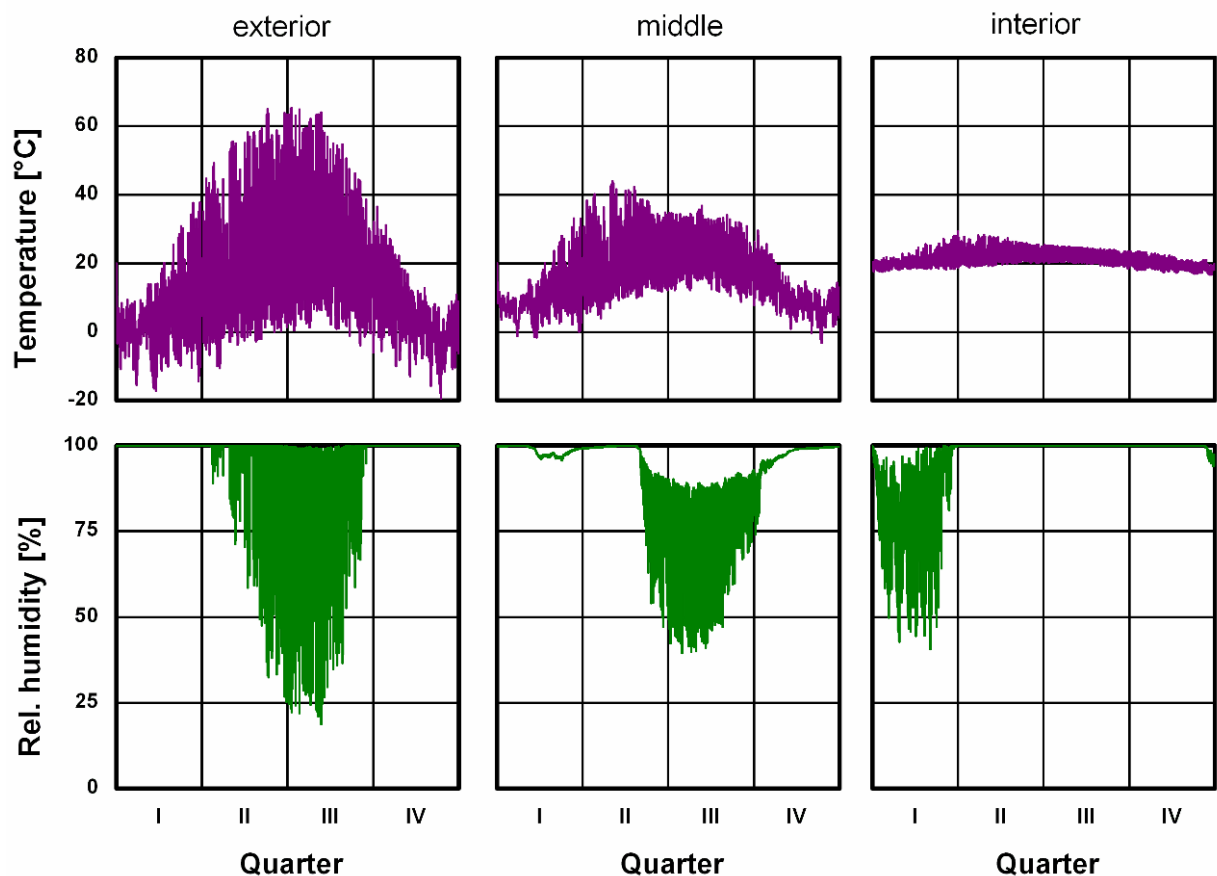
Figure 32: Calculated temperature and humidity conditions at different positions within a flat roof with 175 mm glass fibre insulation in Copenhagen.

Figure 32 shows the hygrothermal conditions at the three positions in the insulation of the flat roof with 175 mm insulation. The temperature at the exterior position shows a very similar behaviour as for the roof with 90 mm in Figure 29.

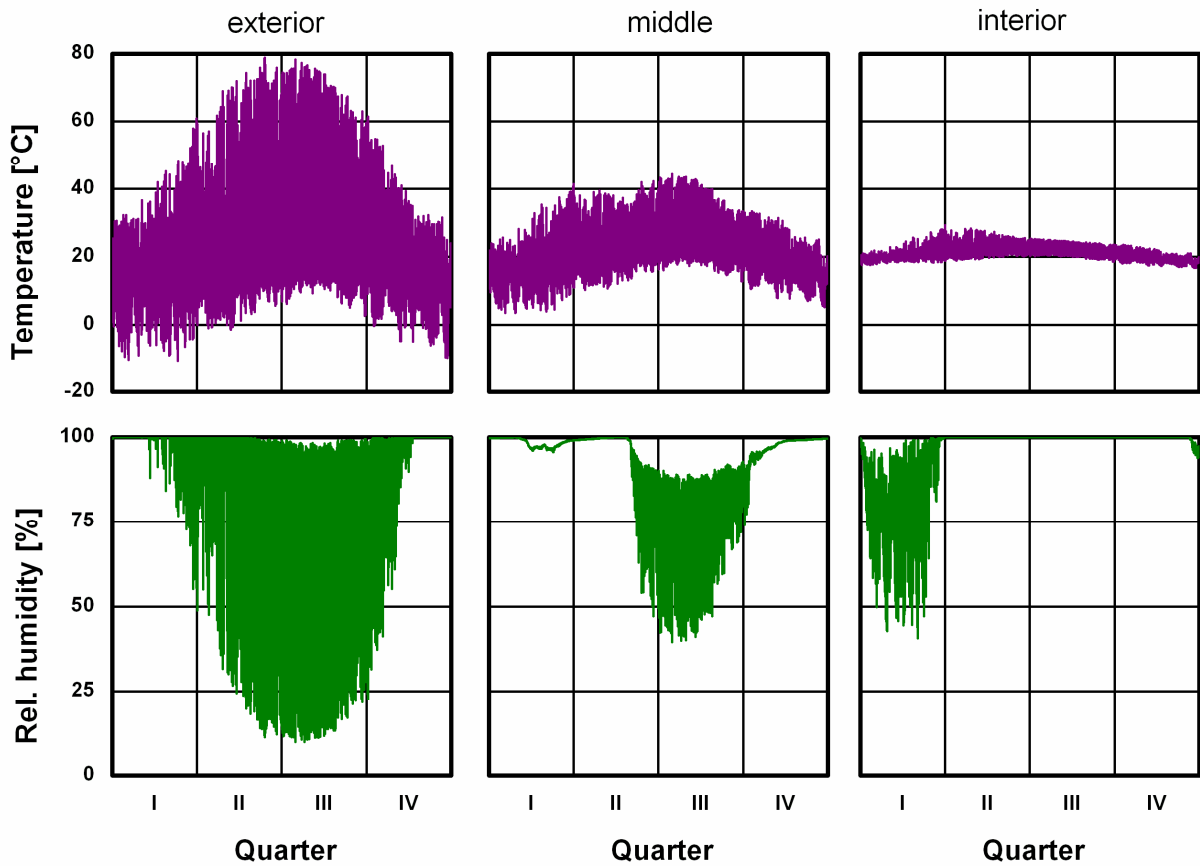
Figure 38: Calculated temperature and humidity conditions at different positions within a flat roof with 175 mm glass fibre insulation in Naples.

The temperature and humidity plots of the flat roof containing an 175 mm insulation layer are shown in Figure 38. As expected the temperatures are very similar to those in the thinner roof with a smaller variation at the middle and the interior part of the insulation. The distribution of the coincident temperature and RH in Figure 39 shows also a similar shape as in the roof with 90 mm of insulation - only the RH values at high temperatures are slightly higher. The hourly classification of the simultaneous RH and temperature in Figure 40 differs hardly from bar diagram in Figure 37 for the roof with 90 mm insulation. The values in Table 4 show, that the number of hours with 90 to 100 % RH decreases from 6600 to about 6400 while conditions above 80 % RH and 40 ° occur just 91 hours a year, a little less than in the roof with 90 mm insulation.
