POMPEII SUSTAINABLE PRESERVATION PROJECT (2023)

Conservation of Circular Tomb PXXIV 13 in the Necropolis of Porta Nocera, Pompeii

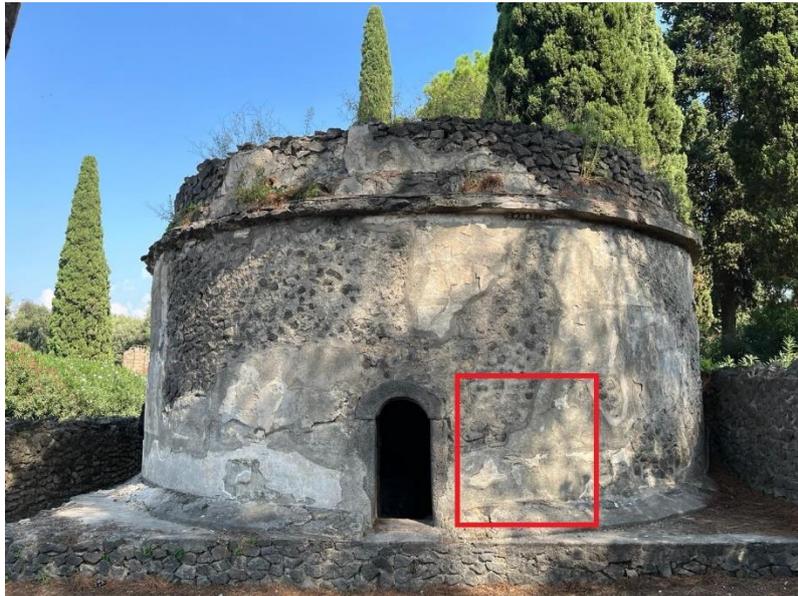
Image showing the Tomb PXXIV 13 and highlighting the area worked on

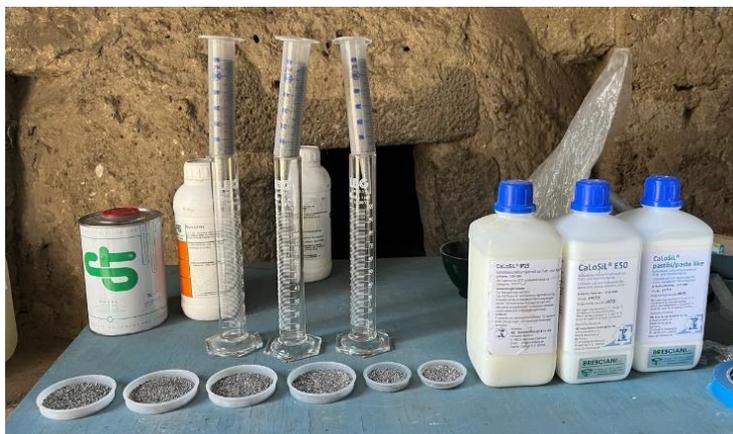
Preparation of the conservation tests

Treatment Performed: Prior to initiating any intervention, discussions were held and compatible materials were identified through testing various ingredients and proportions, which proved to be essential. The tests were devised to determine the suitable consolidant, grout, and fillings for edge repairs, with the following outcomes:

- **Consolidant:** Following penetration and strength assessments, Calosil E 50 emerged as the optimal choice.
- **Fillers for edge repairs:** Intonaco edging, comprising a 1:3 ratio of slaked lime to aggregates, was selected. The aggregates consist of a mixture of coarse and fine yellow river sand particles, along with pozzolana.
- **Grout:** After evaluating the flow, injectability, and shrinkage of grouts formulated from various ingredient proportions, the recipe developed by conservator-restorer and supervisor Leo Borgatta was deemed suitable. This formulation incorporates fillers such as inert quartz powder, and Roman pozzolana; Calxnova “KalkBindemittel” as binder; and water as the dispersing medium.

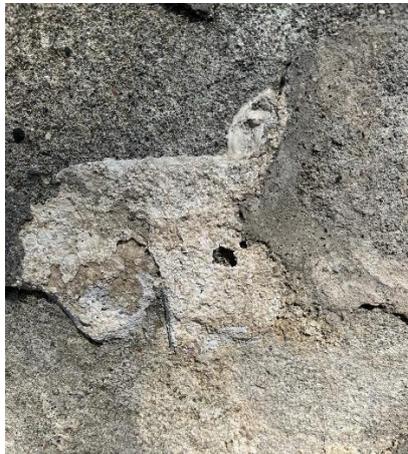
Loss of fragile plaster layer seen in the form of hole which is also completely hollow from inside

2.1 Grouting in hollow layers of plaster

- Prior to grouting, attention was given to facing, using Japanese tissue as a protective layer since the outer plaster/intonaco was weak and fragile. This was applied using Carboxymethyl cellulose. This not only provided additional support but also ensured careful execution during the grouting process.
- Subsequently, grouting was done using a formula crafted by Leo Borgatta, which had proven to be effective during treatment procedure trials. This involved incorporating quartz powder, microspheres, pozzolan, Calxnova, and water into the mixture.

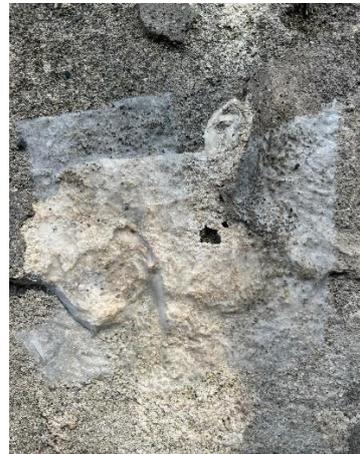
Facing was done first to secure the fragile plaster layer

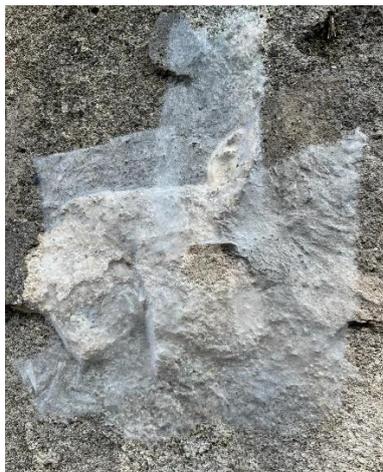
After grouting

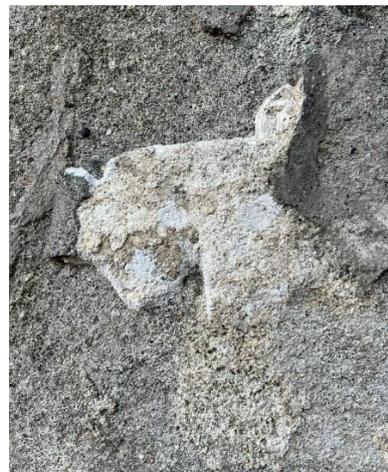
After conservation - The plaster layer has now been secured and facing removed carefully

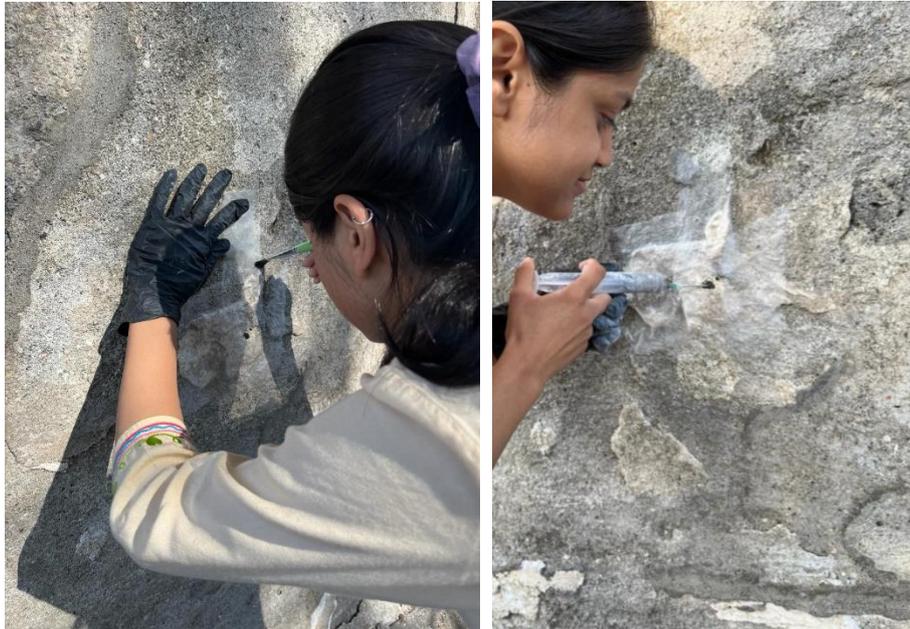
Working shots of during conservation efforts: Applying facing layer (left), Grouting (right)

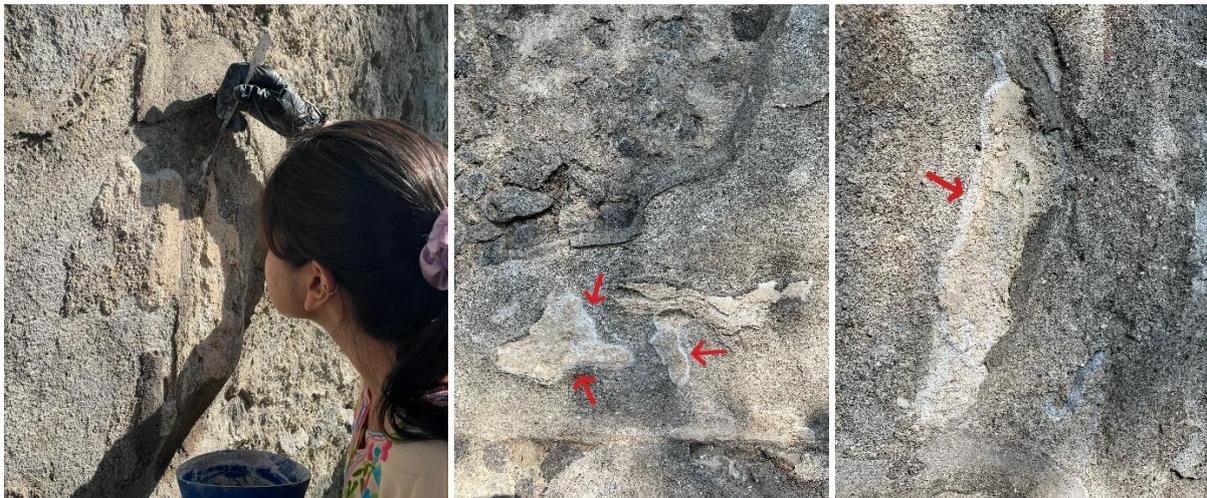
Images depicting the executed edging repairs

2.2 Edging repairs for layers of plaster:

The fillings for edging repairs in the finer (intonaco) plaster layer were prepared in a ratio of 1-part slaked lime to 3 parts sand (as discussed above), with the incorporation of yellow pozzolana (pozzolana gialla).
