## Report Conservation Treatment on the North-East Wall of Tomb 3

| Object | Tomb Nr. 3, part b (north-east) outer wall |
| Location | Necropolis Porta Nocera, Pompeii, Italy |

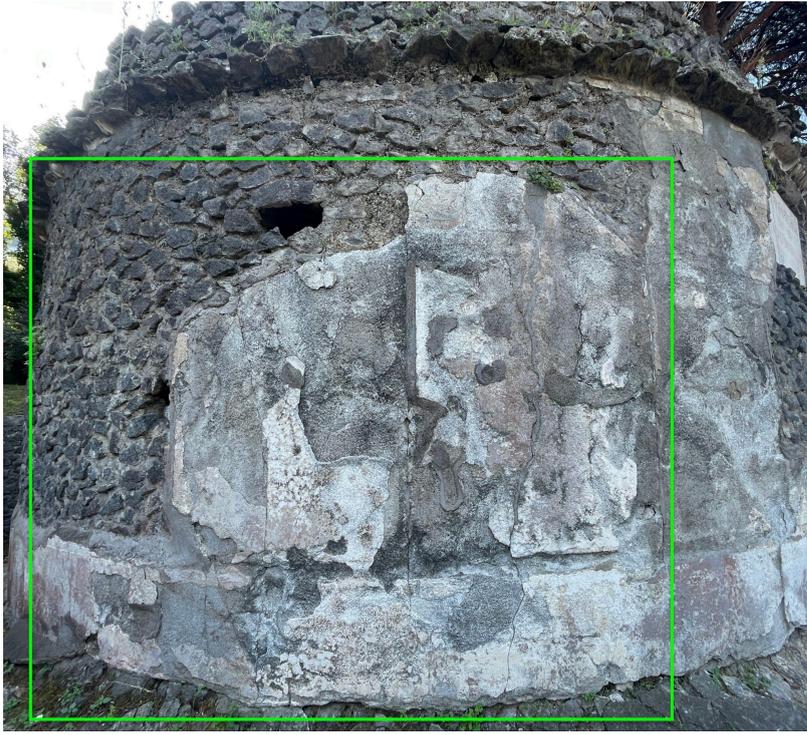
In this area there were multiple endangered areas that were at risk for loss if not treated. There has been loss of adhesion on multiple layers which led to detachments and scaling. In large parts the whole plaster layer showed a detachment from the masonry. In some parts the gaps between masonry and plaster were very wide, up to 2 cm. Detachment was also visible in the other layers of the plaster. In the intonaco there were small parts that were affected by loss of cohesion in addition to the detachment and that were severely endangered of loss. In some gaps between the detachments plants and insects are visible. All plaster layers show discoloration, supposably caused by biological infestation.

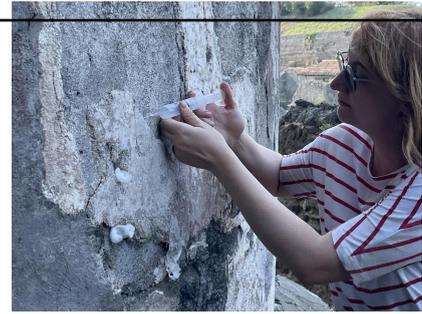
Prewetting before injection of the backfilling

Due to time constraints the detachments from the masonry were not treated in this area. The detachments within the plaster layers were treated as they also seemed to be more fragile and at risk of loss. The first step was to mechanically clean the areas that were to be treated. In the gaps of the detached layers dust and plaster residues were blown away with an airball or gently removed with brushes and spatulas. If the gaps were open at the bottom these areas were firstly closed with mortar. After that the gap was wet first and injected with backfilling (Leo's recipe) after. After this all open gaps were closed with edging repairs. One problem with the edging repair was to match the color as the discoloration in this area was very diverse. In two very fragile areas that were also affected by loss of adhesion a facing with methylcellulose and japanese paper was applied, so the area would not collapse under the weight of the edging repair and the backfilling. The facing was removed as soon as the treated area was set and cleaned with water and a cotton swab.

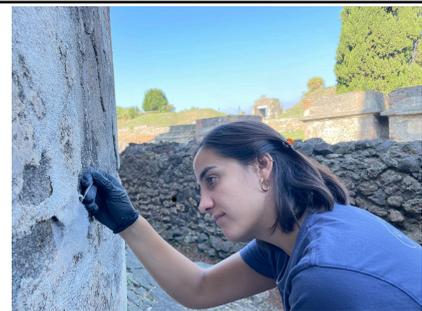
Edging repair
