Pompeii Sustainable Preservation Project

Summer School 2023

Activities report

15.01.2024

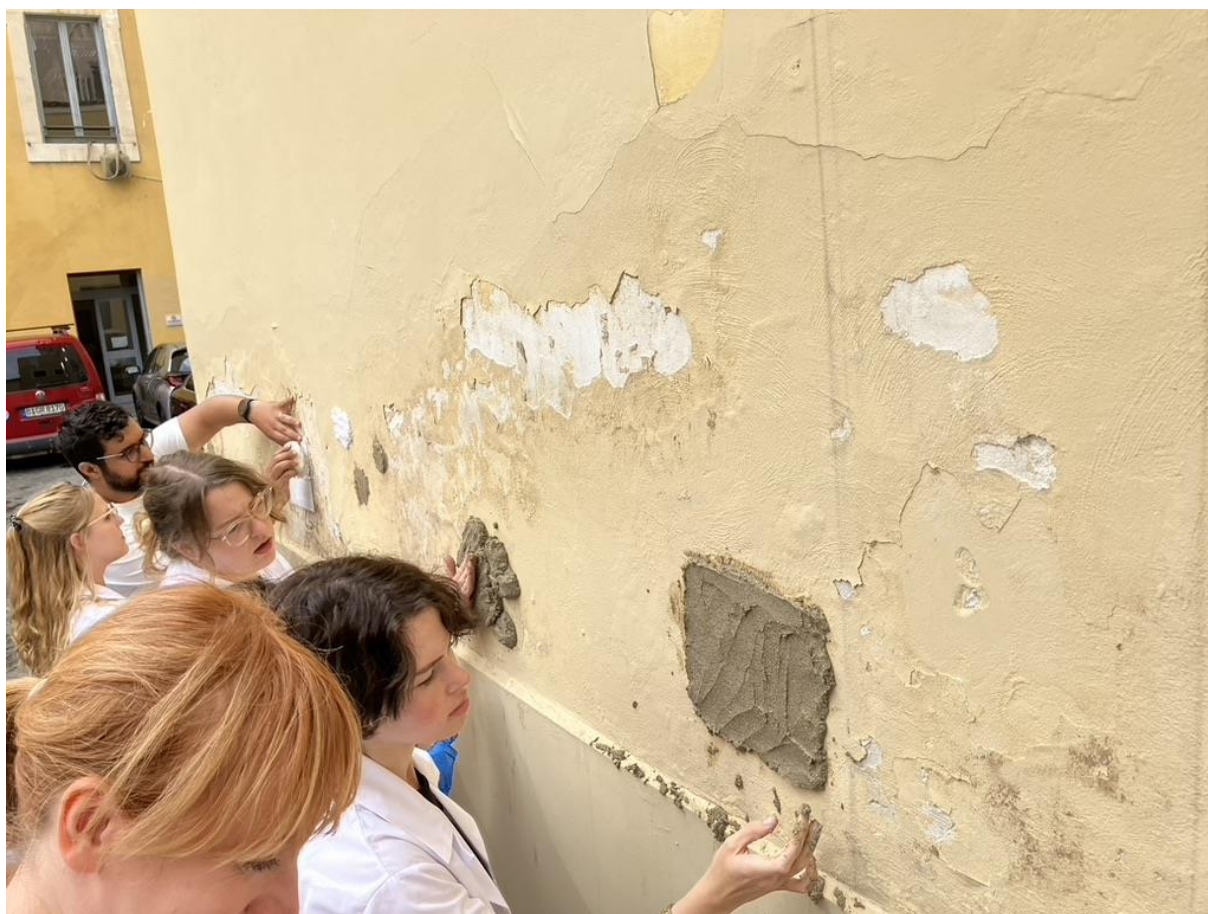
Figure 4 Participants applying salt-reducing poultices in the courtyard of ICCROM headquarters.

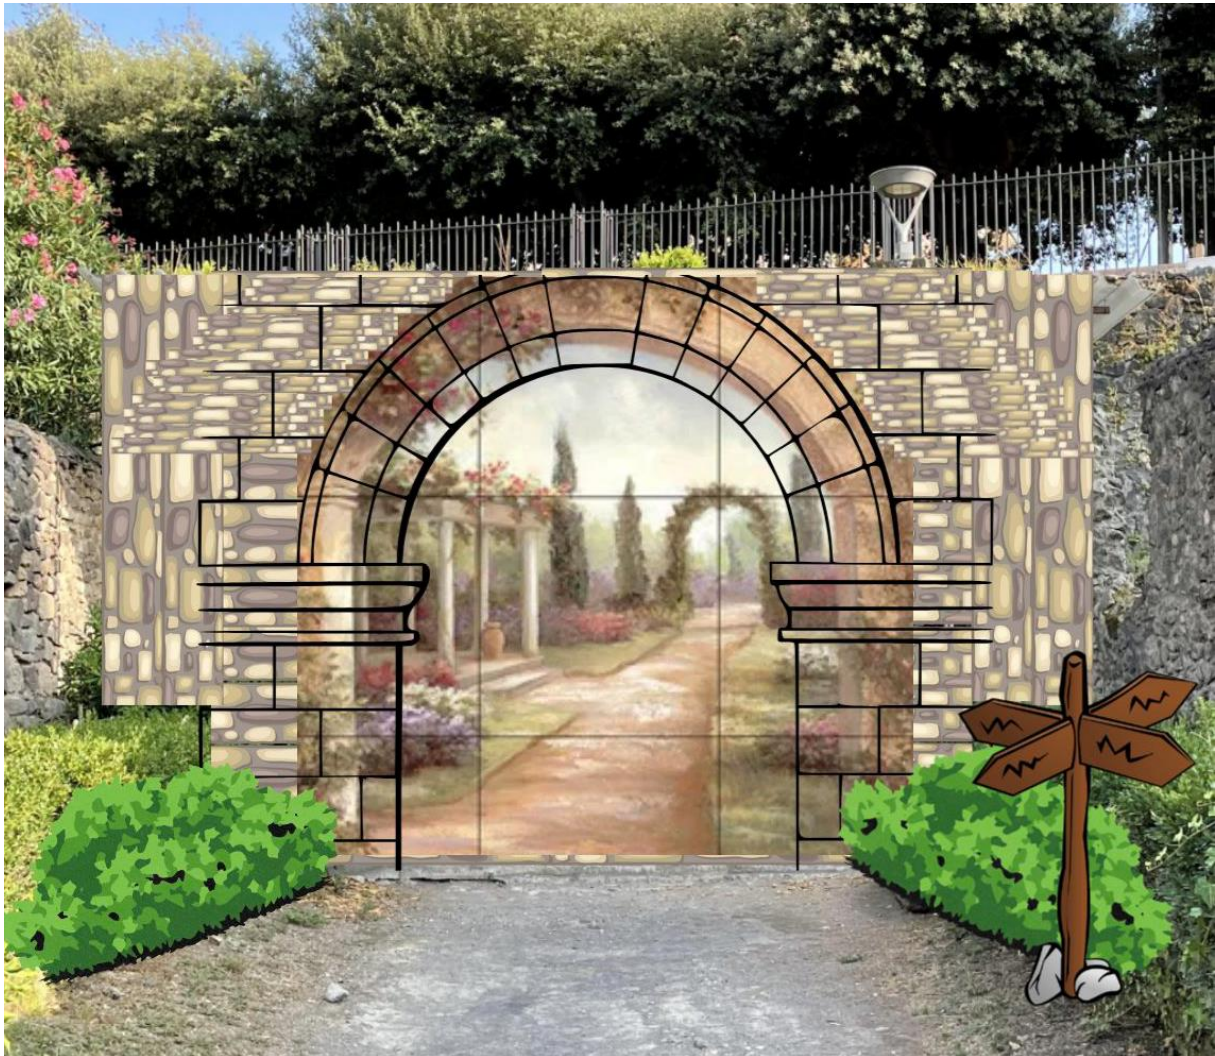
Figure 7 3D model of one of the participants' suggestions for redesigning the area where the stone elements are now exhibited.

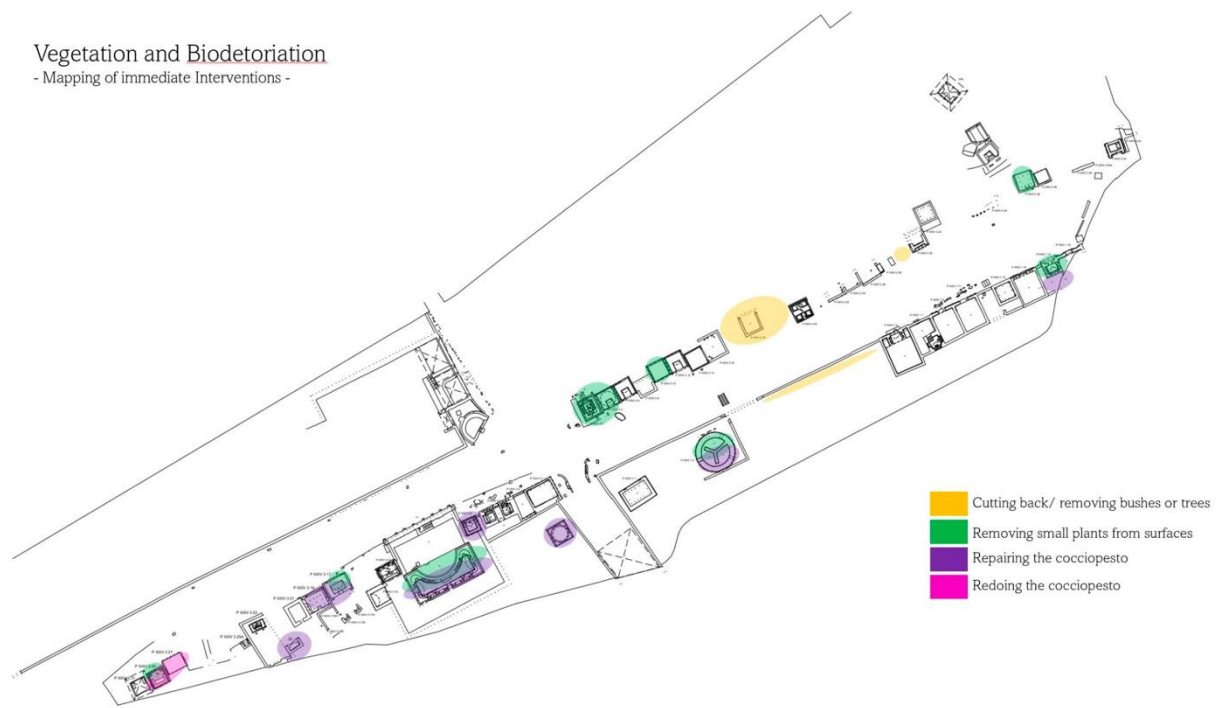
Figure 8 Map of immediate interventions concerning vegetation and biodeterioration developed by the participants

Maps of the distribution of the vegetation (cause) in the necropolis and biodeterioration (consequence) visible on the decorative surfaces and masonry of the tombs, were produced in order to observe causalities by superimposing them. By comparing the maps, clear correlations between the significant presence of vegetation in the necropolis and mechanical deterioration (e.g. pressures in plaster and tomb structure due to plant growth) or physico-chemical deterioration (microbiological growth on tomb surfaces) can be observed. This year's survey focused also on what can be done immediately to slow down deterioration processes (fig. 8). The participants propose to:

- Cut back/ remove certain bushes or trees
- Apply biocide and remove small plants from the tombs’ surfaces
- Repair the protective layers of *cocciopesto*

- Completely redo the protective layers of *cocciopesto* when they are too damaged

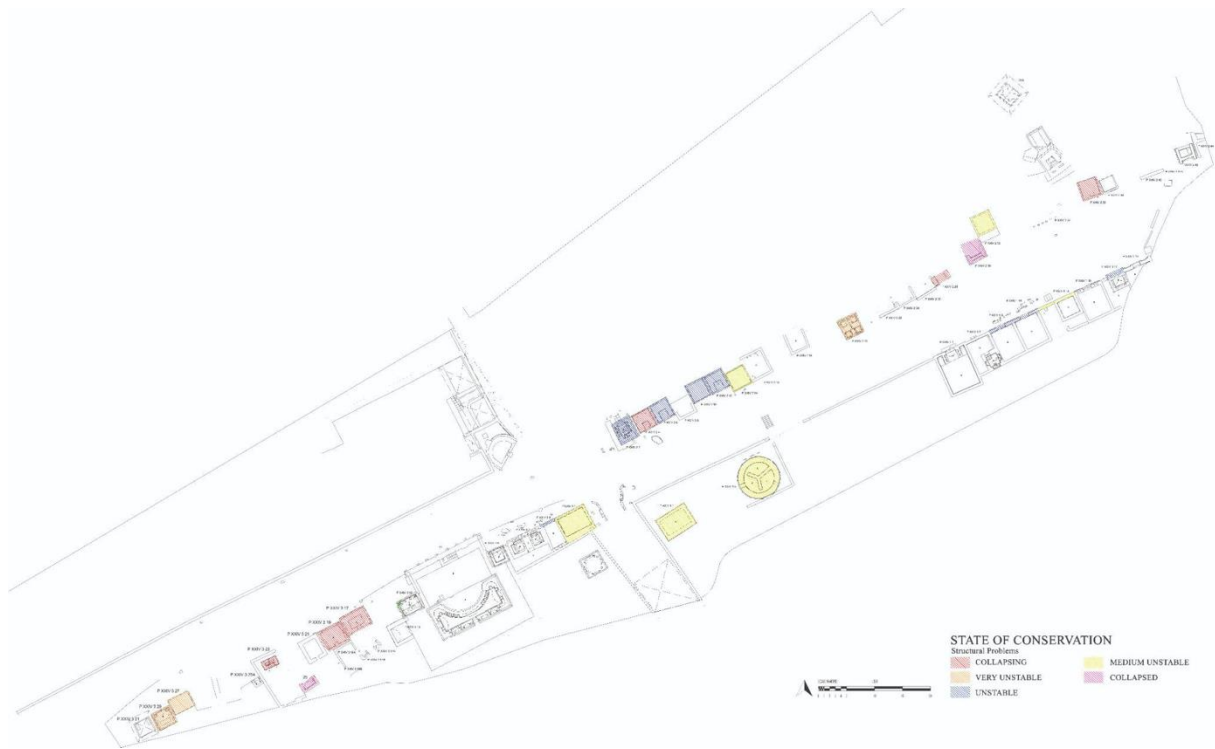
Figure 9 Map of the state of conservation of the tombs' structures developed by the participants

The map-based survey of the structural integrity of the tombs in the necropolis is a key document, as it provides rapid information on the (often precarious) state of conservation of the tomb structures (see fig. 8). Carried out this year by architects experienced in the field of heritage conservation, the study classifies the state of conservation of tomb structures into five categories:

Two tombs (P XXIV 2 30 and PXXIV 3 25) are already considered "collapsed". There are also six tombs (P XXIV 2 36, PXXIV 2 30, PXXIV 2 28, PXXIV 2 4, PXXIV 1 17/19, PXXIV 1 23) with "collapsing" status. These tombs are a **real danger** to visitors walking around them, as they could collapse at any moment. They need **urgent structural intervention** (!)

For each of these tombs, a map-based survey has been produced outlining the studies and additional work to be carried out (see fig. 9).

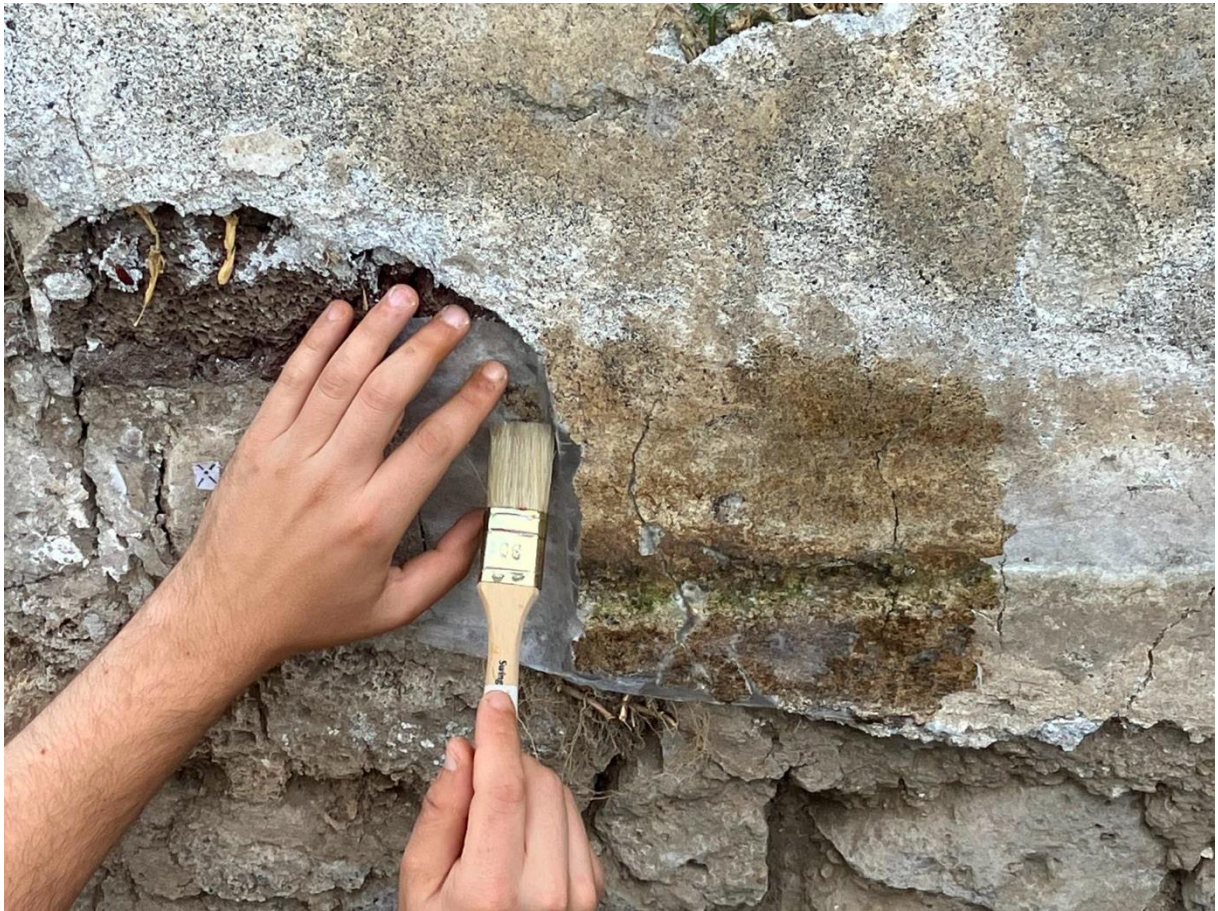
Figure 12 Application of a facing to temporary secure plaster using Japanese paper and carboxymethylcellulose

First measure to be undertaken before every operation is to **secure loose original materials** that could fall off while doing other treatments. In order to do that, the **facing** method was used. This method consists of applying a piece of Japanese paper to the unstable plaster area using a

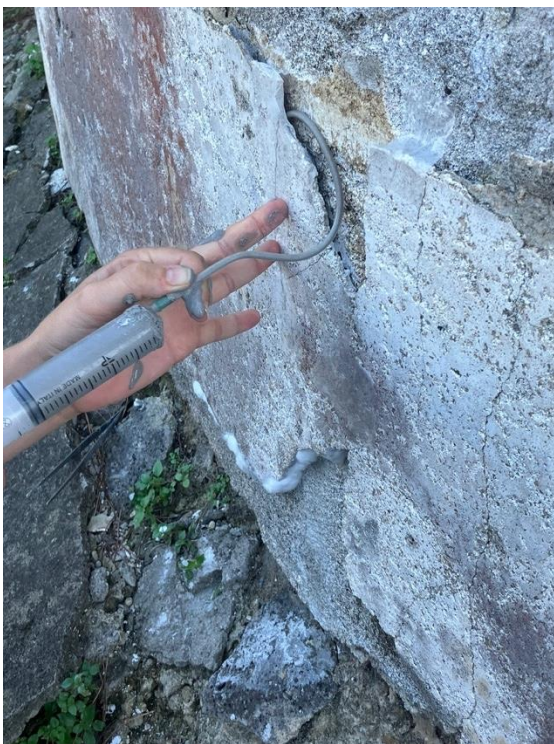
Figure 13 Grouting of the voids caused by the detachment of plaster layer (intonaco)

- The voids are grouted using the homemade grout described above (fig. 13). Wide detachments are grouted with the foam mortar.
- After the setting of the grout – generally waiting for at least a day – the edges of the delaminated plasters are closed using mortar recipe for *arriccio* or *intonaco* plaster layers (fig. 14). In certain cases, the loose plaster aggregates around the edges have to be consolidated, using CalsoSil IP25 or CaloSil 50 prior to the application of the edging repair mortar. This is in order to have a good connection between the restoration mortar and the original one. Consolidants can be also used for pre-consolidation of loose particles inside the void before grouting if necessary.

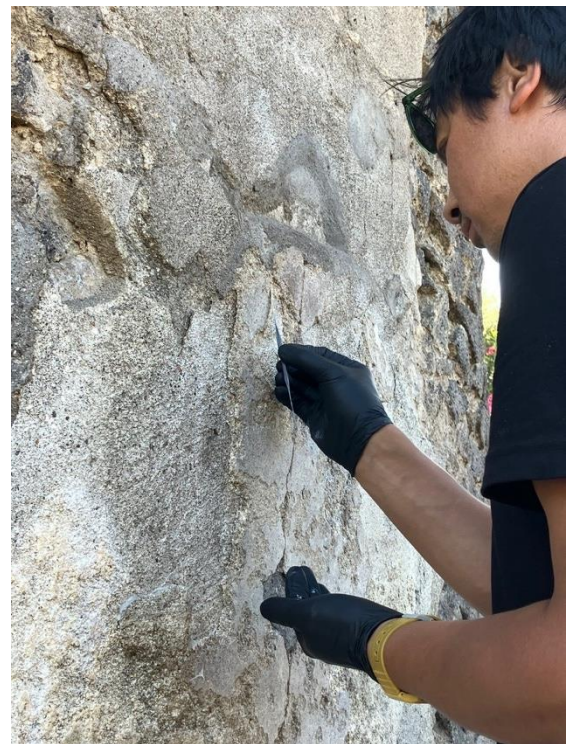
Figure 14 Application of restoration mortar to close open edges caused by the detachment of plaster layer
