CONSERVATION REPORT, PORTA NOCERA NECROPOLIS, POMPEII

TOMB PXXIV 13

OCTOBER 2023

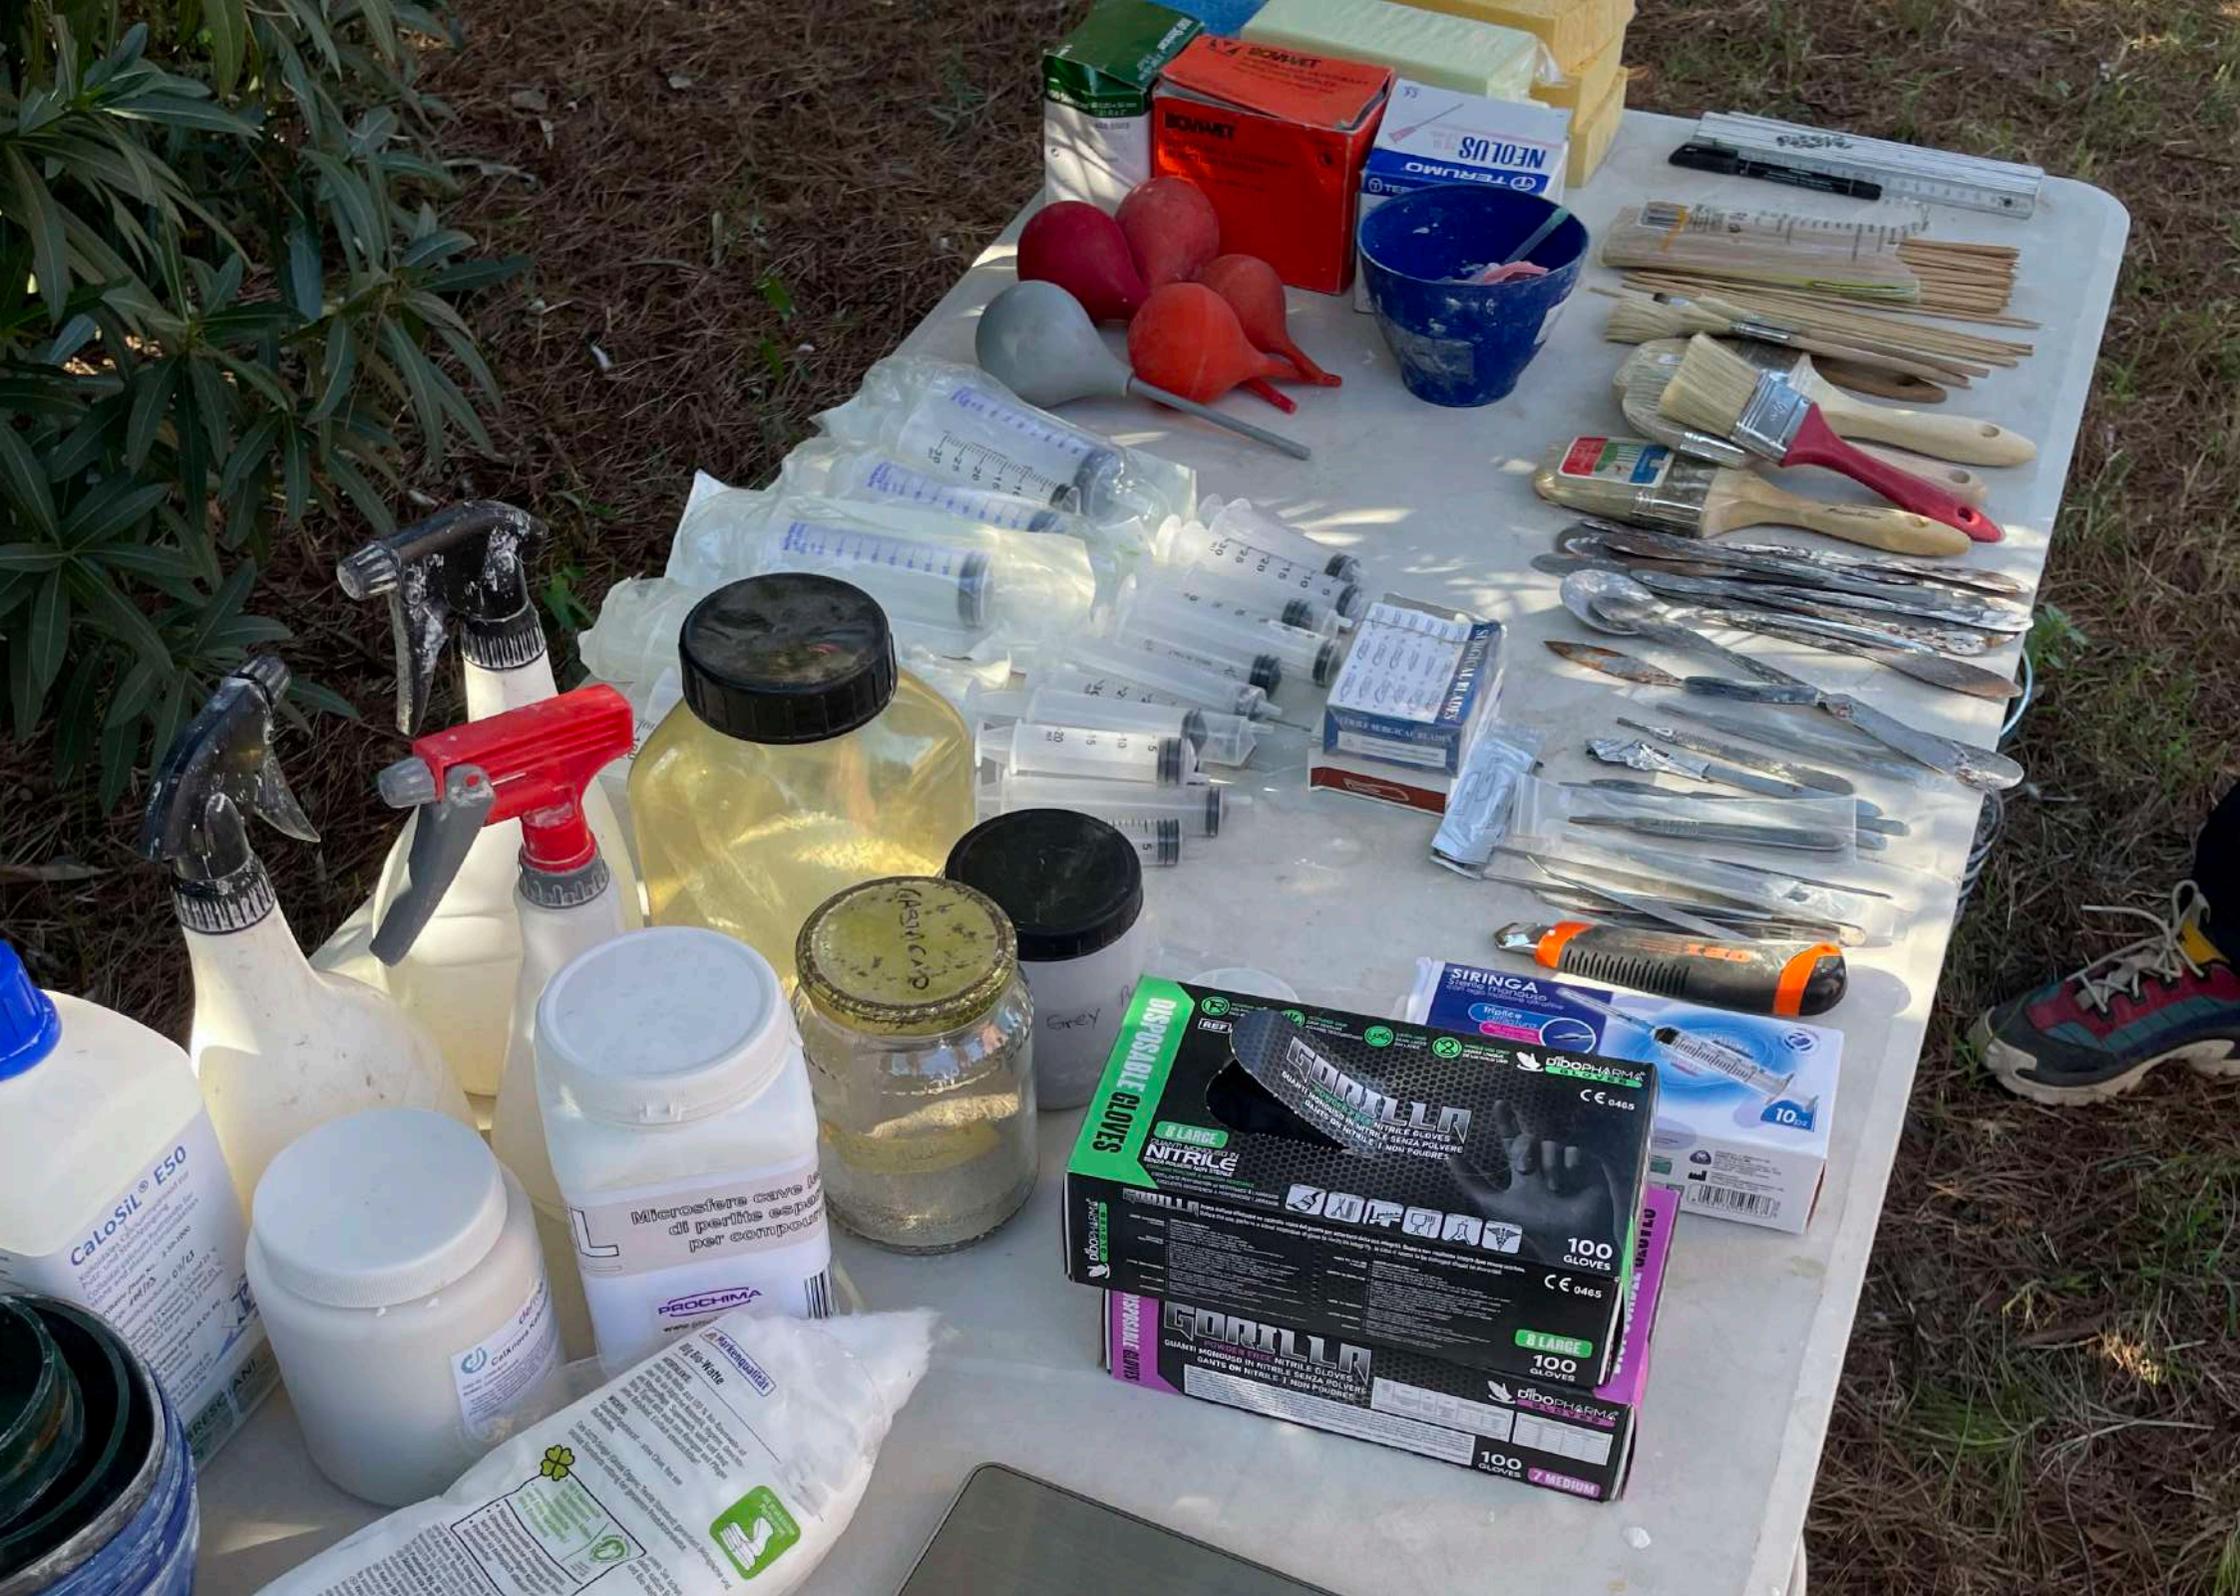
CaLosil® E50

Microsfera con di perite espansi per composti

PROCHIMA

GELATINA

GORILLA
DISPOSIBILI GLOVES
LARGE
100 GLOVES
CE 0465
dibopharma

SIRINGA
10
dibopharma

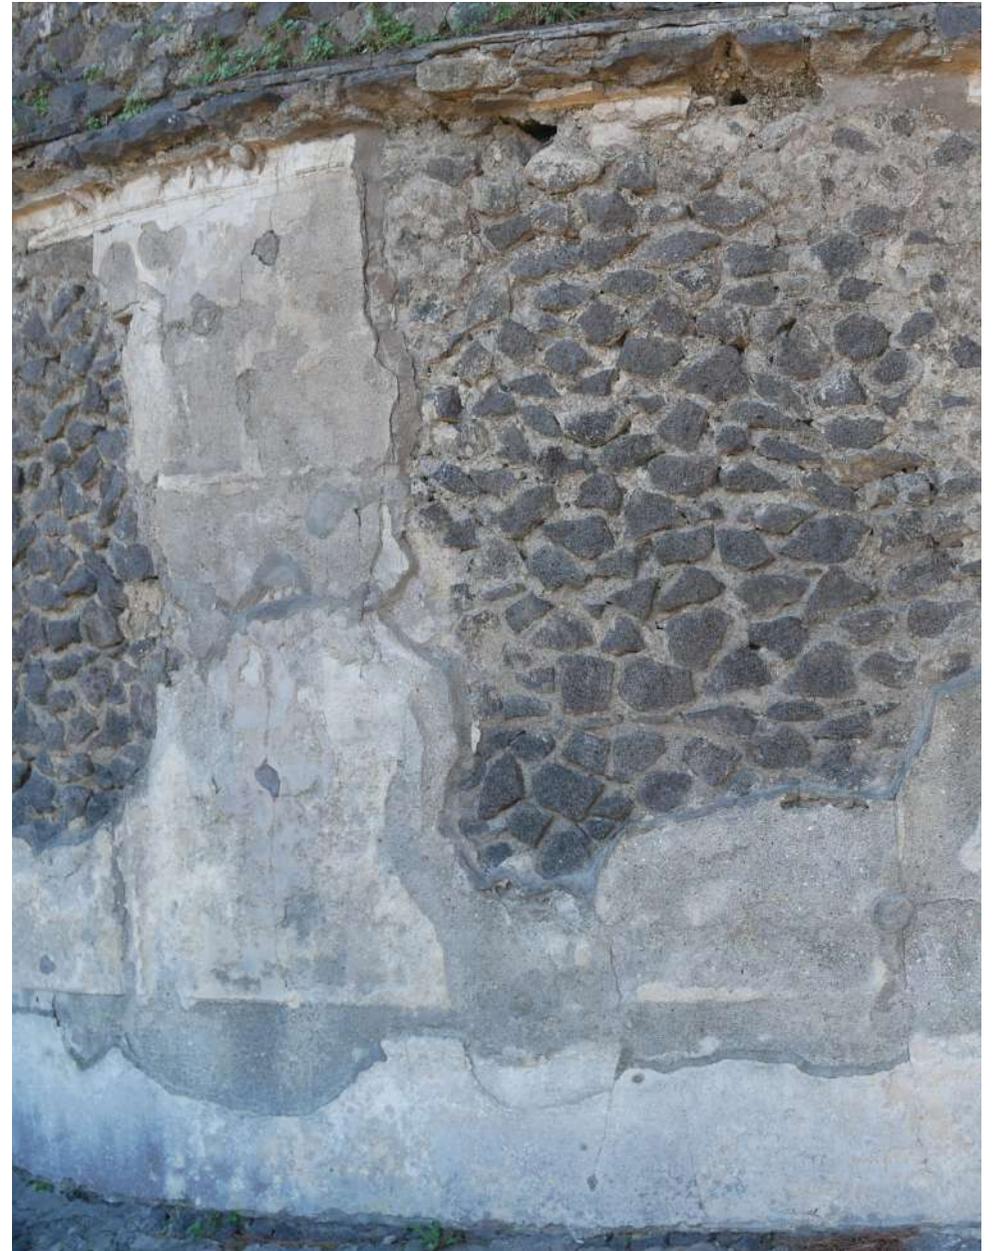
The internal core structure of most of the buildings is mainly made of opus caementitium, a mixture of lava stones + brick fragments + a lime based mortar containing coarse and medium size volcanic sand

Opus caementitium

This building technique is generally diffused for the entire monument. It constitutes the inner core conglomerate composed by volcanic stones, fragments of stone or terracotta, sand (in coarse and medium granulometry) and lime.

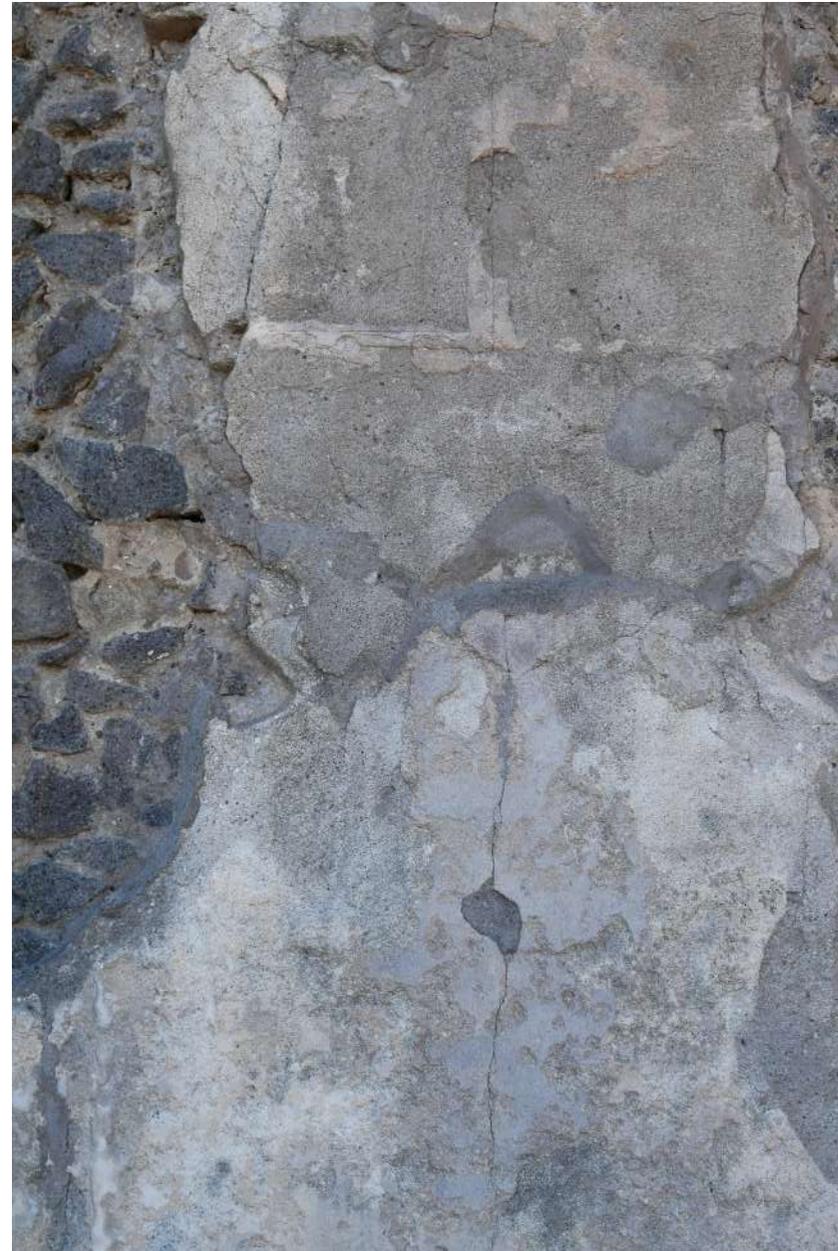
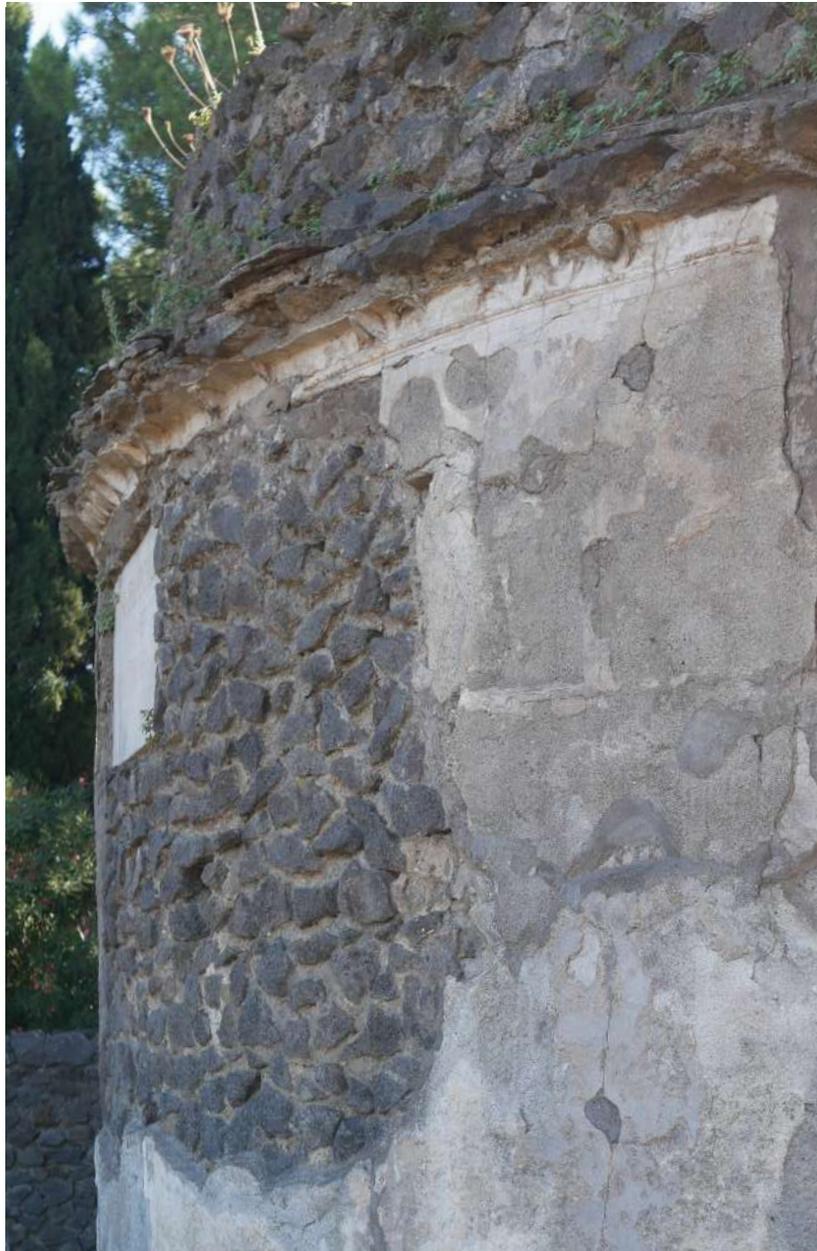
*Stucco was applied as three dimensional decorative elements
in Tomb P XXIV 13*

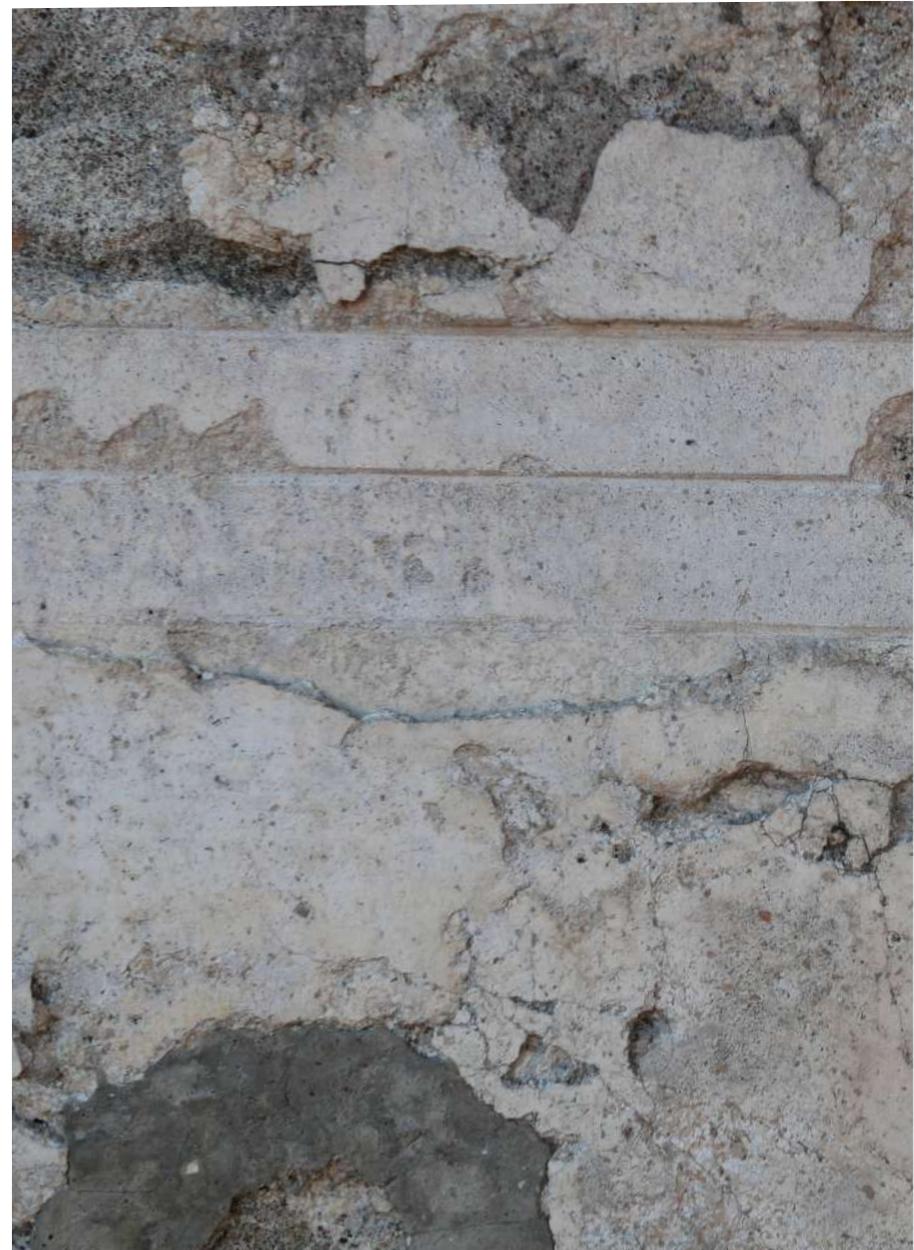
Based on historic imagery and understanding of Roman plaster and decorative surfaces, Tomb PXXIV 13 would have boasted a fresco paint layer as part of its original technology. Although the paintings have been lost and are no longer interpretable, faint remains of the paint layer are observed in localised areas throughout the top coat plaster layer which maintains some orange, black, and red pigment.

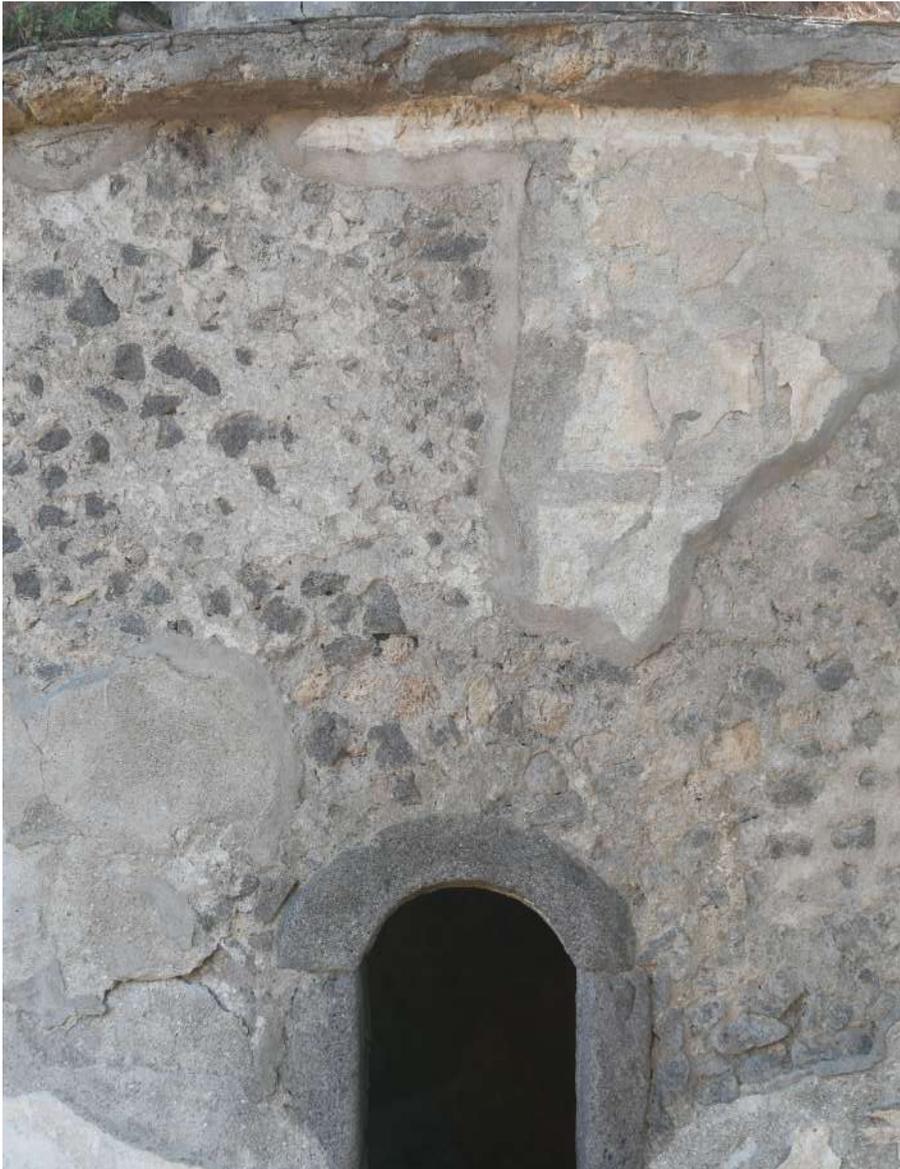
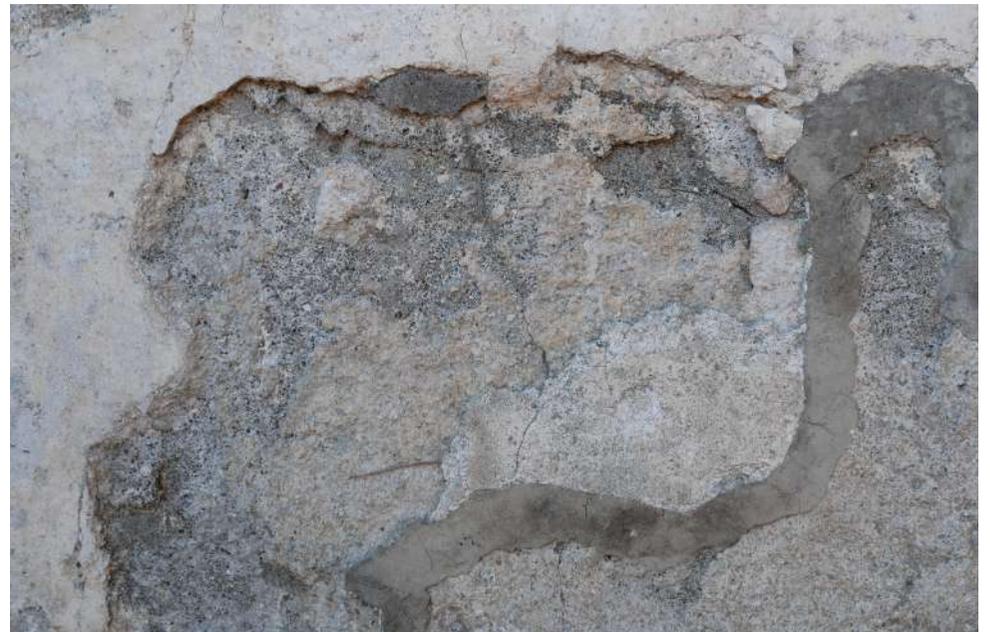
Loss of the primary support is characterised by loss of components or sections of the masonry and mortar construction.

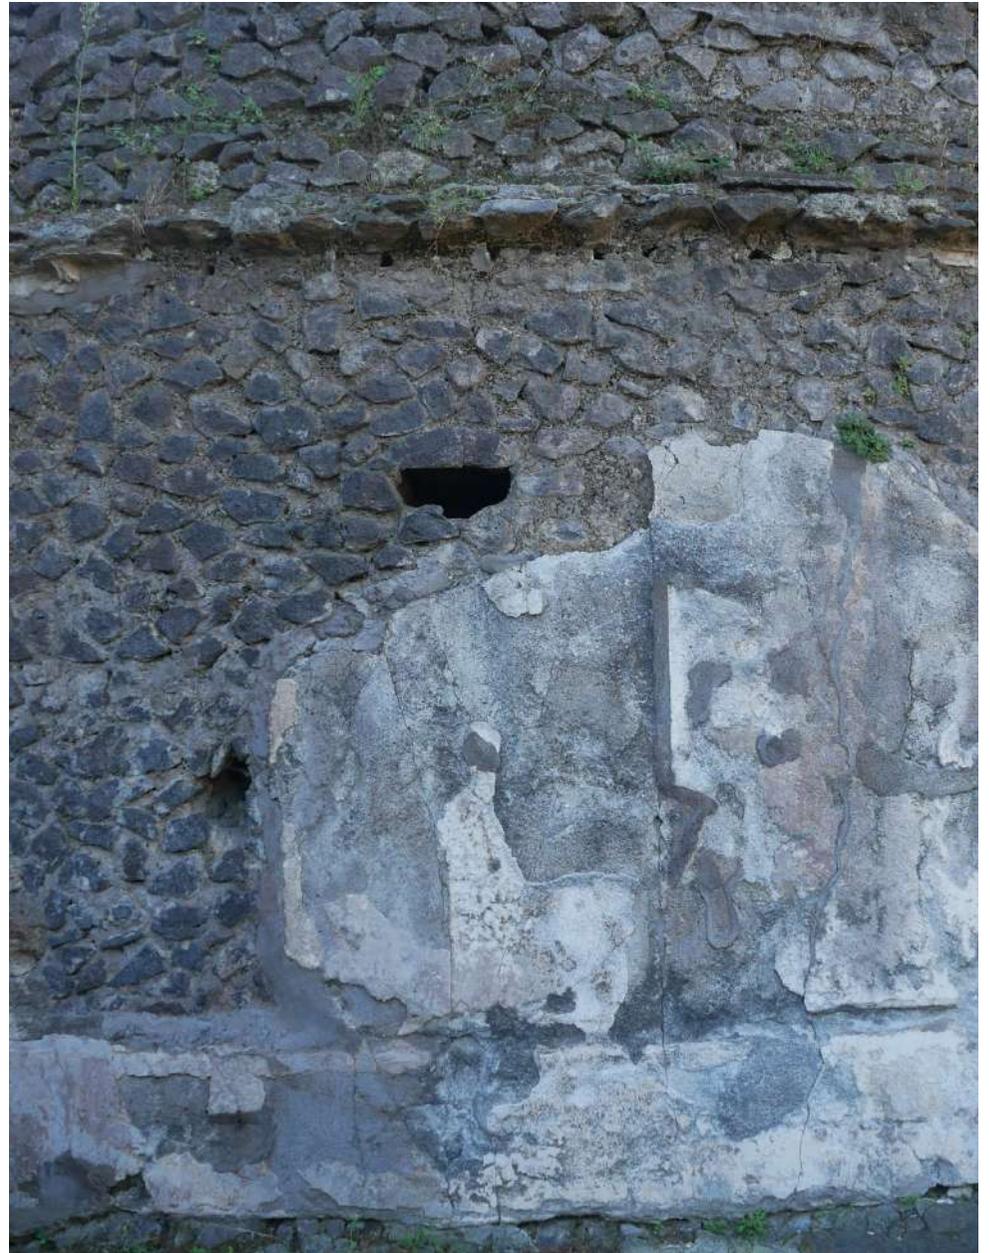
Mortar decohesion refers to areas where the mortar has been eroded or is actively decohesive in between the brick or stone masonry components.

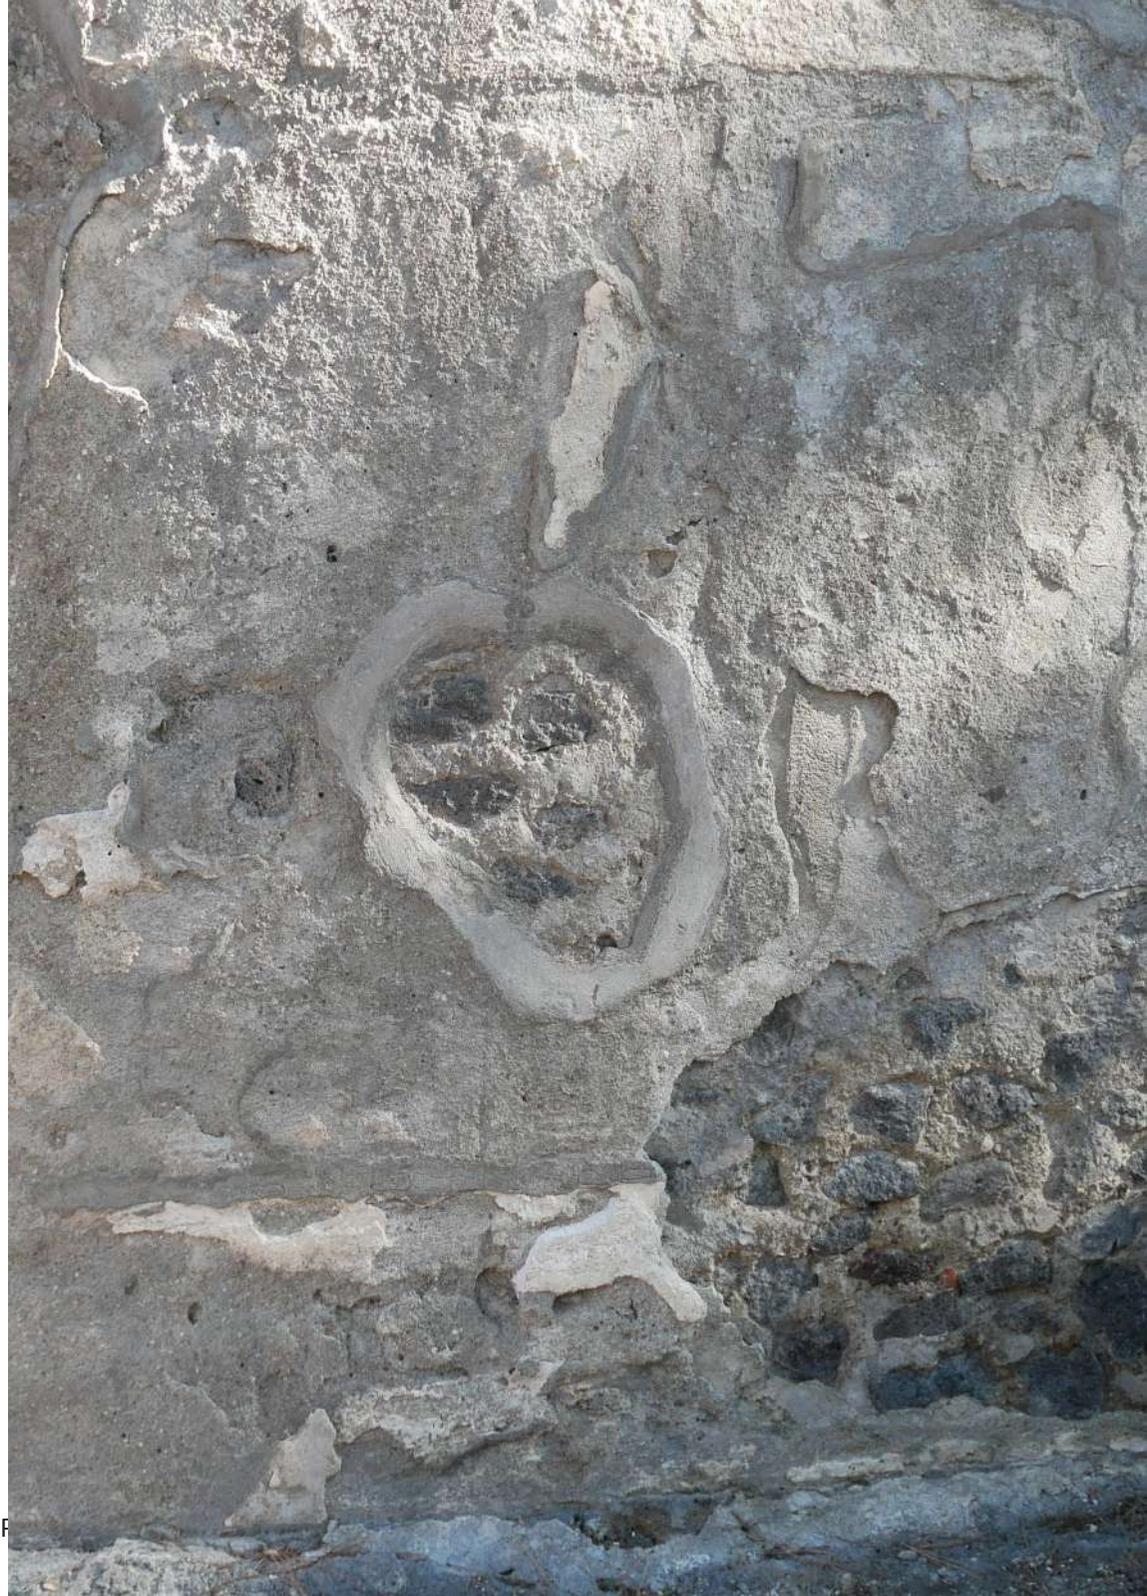
Loss of the secondary support refers to areas where the plaster layer has been lost to reveal the layer below. This can affect one or multiple layers of the plaster, exposing the supporting plaster layer or primary support.

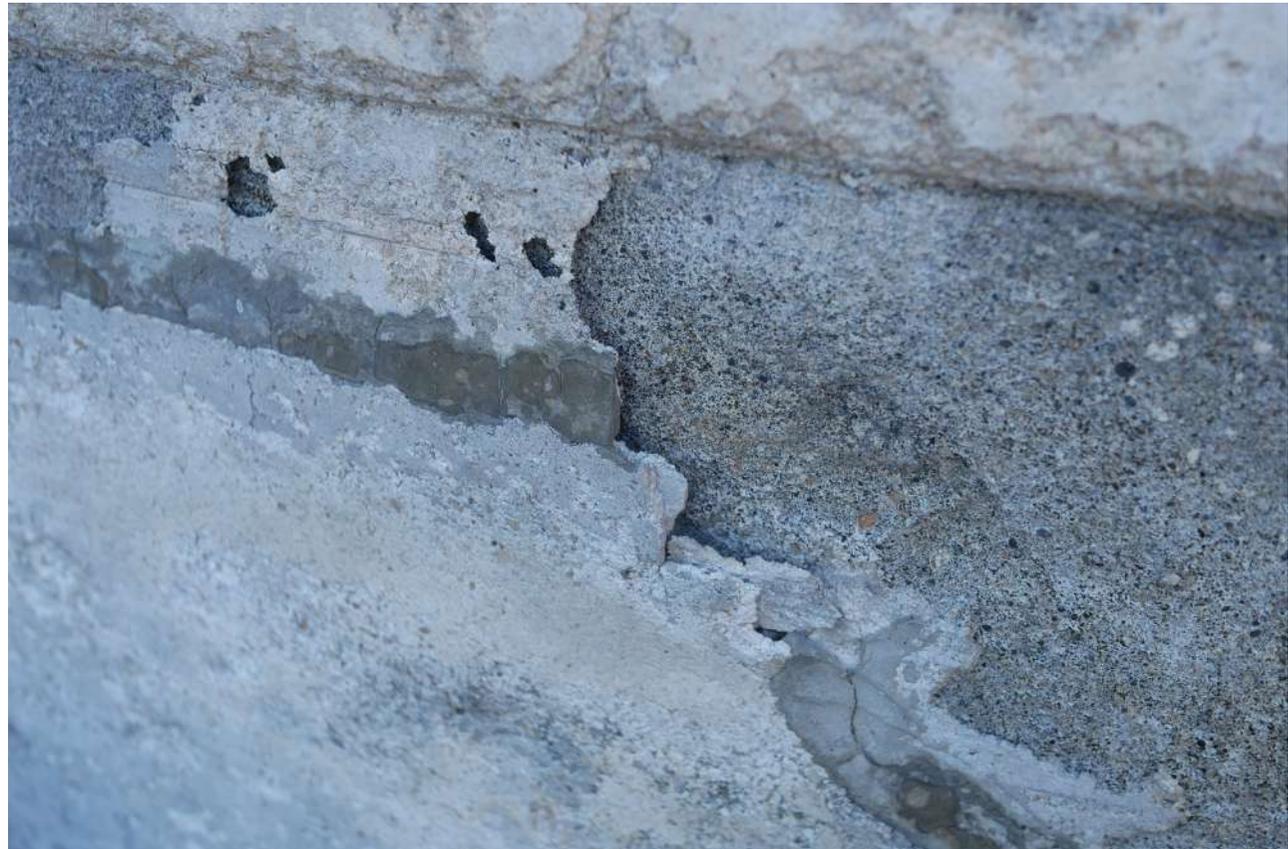
Exposed edges refer to the perimeter of remaining plaster layers where loss has occurred. Exposed edges reveal the remaining plaster layers that are now unsupported and vulnerable as they are no longer secured to the primary support.

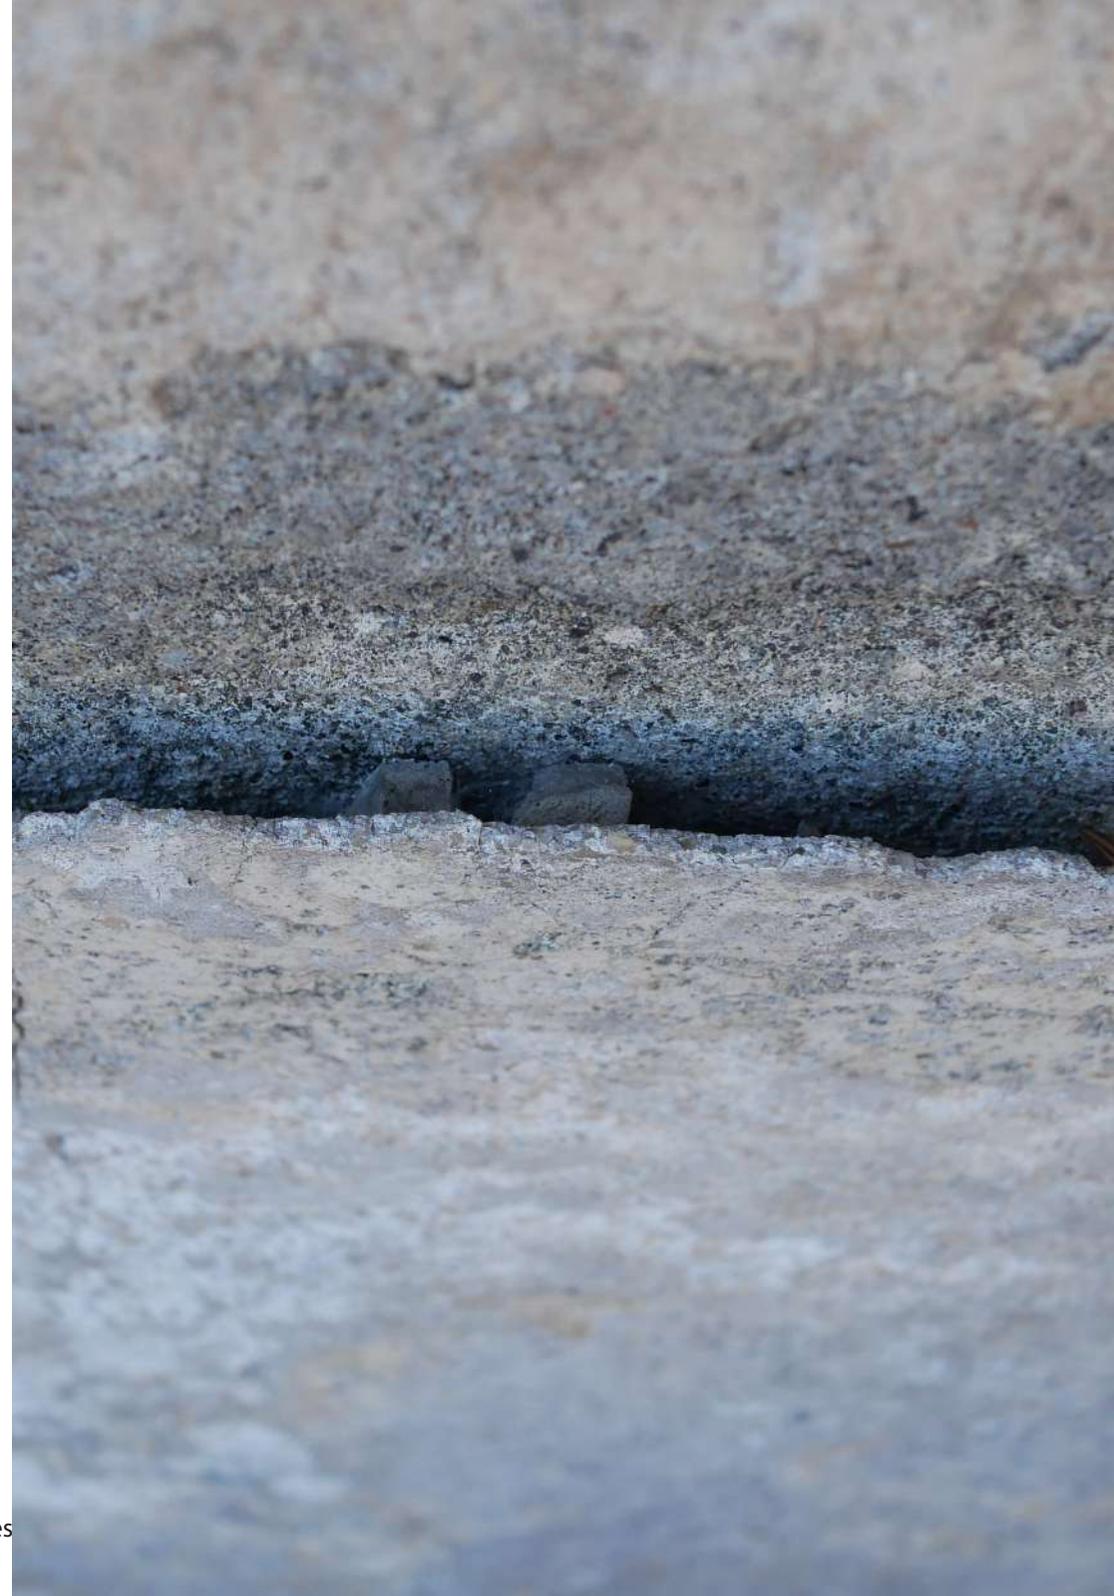
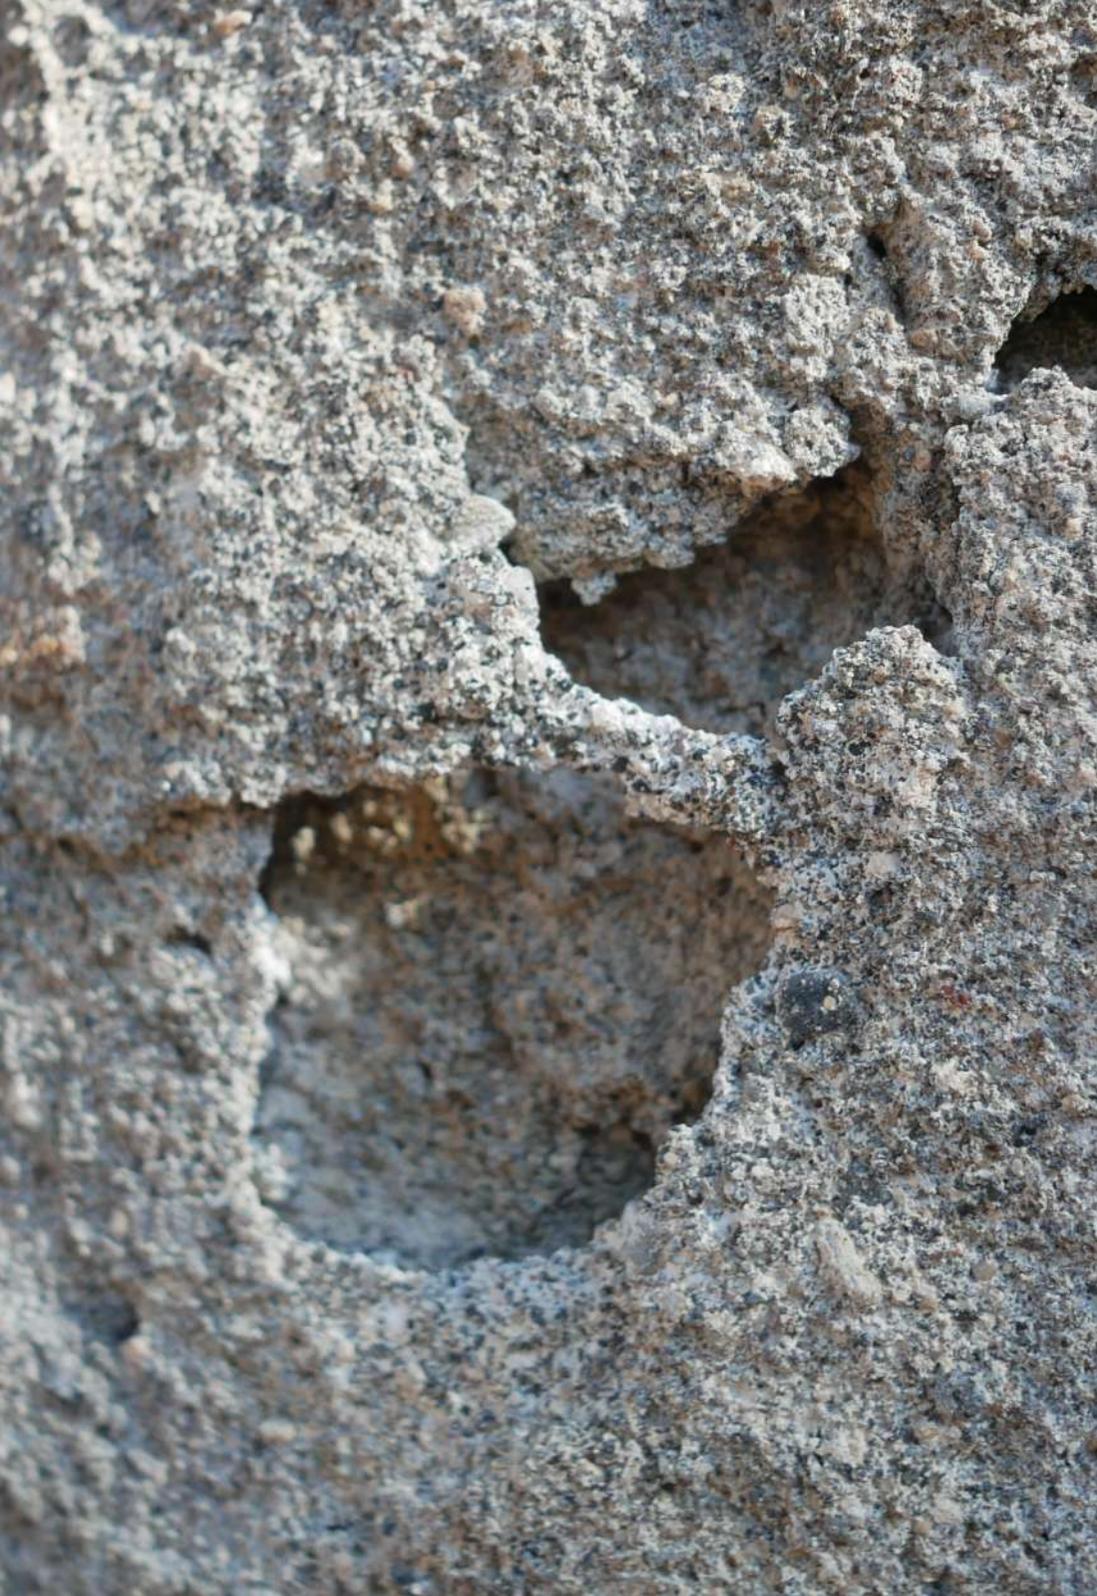
Detachment refers to the full separation of the base coat plaster layer from the primary support. Detachment is often observed as a visible gap between the plaster layer and the stone masonry at an exposed edge or area of loss, however may occur within a plaster layer as determined through tap and feel sounding.

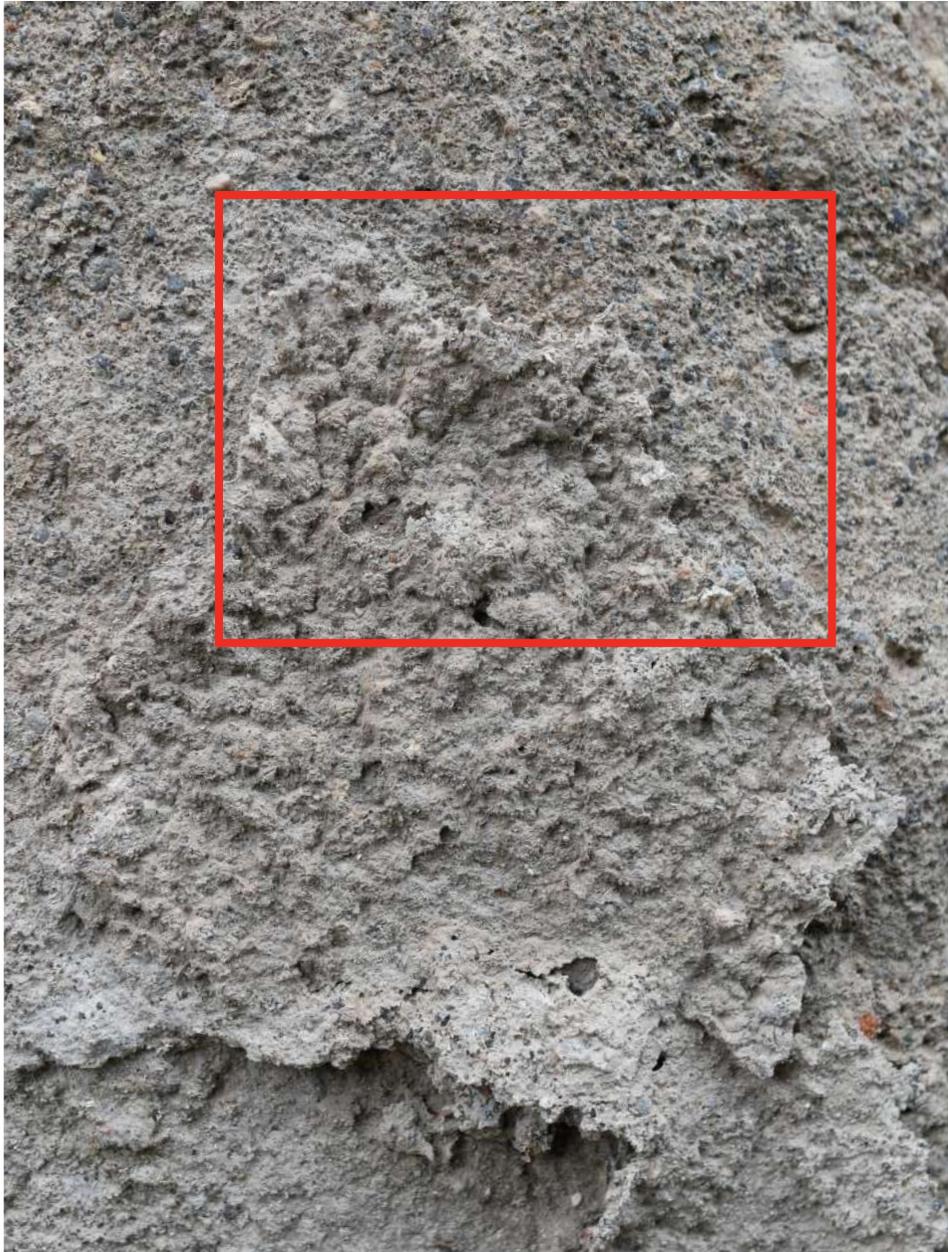
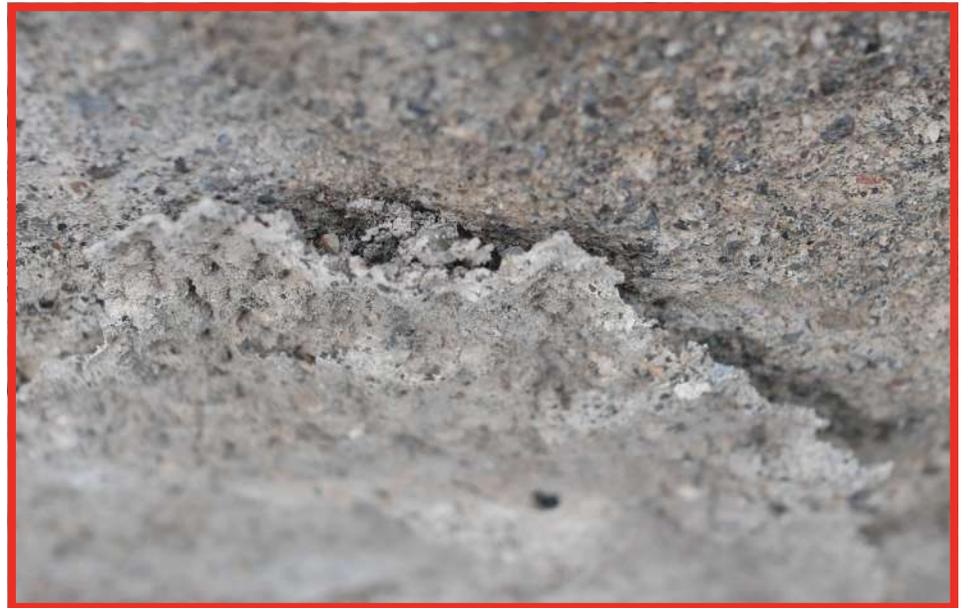
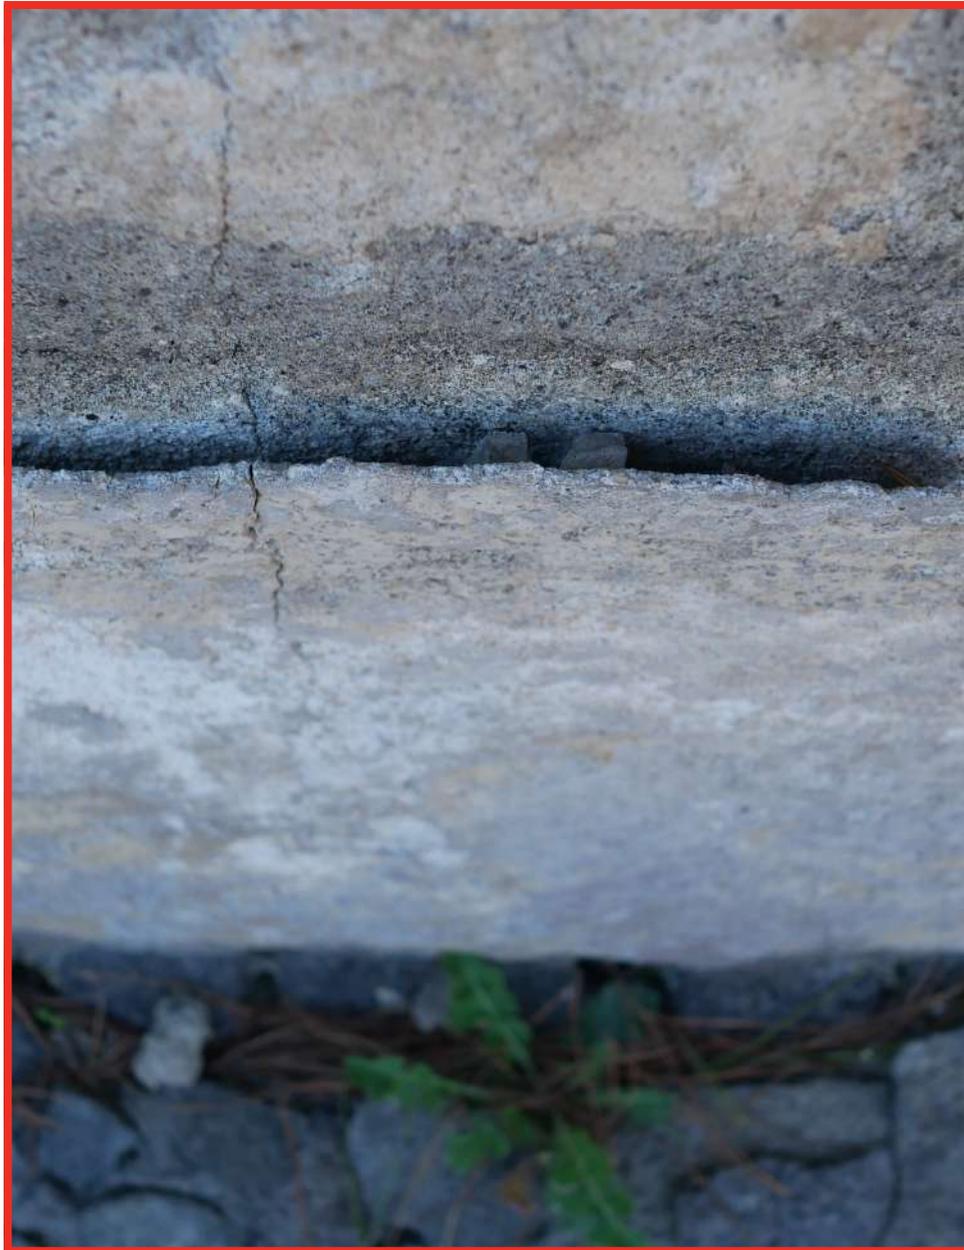
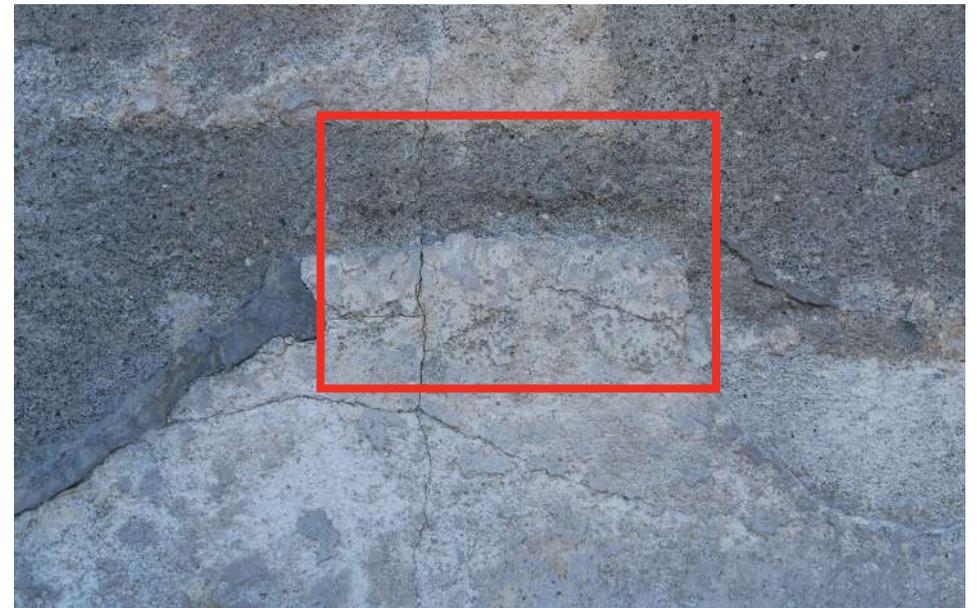
Delamination refers to separation between plaster layers. This may occur between the first, second, and/or top coat plaster layers, and results in visible or sounded space between layers.
