CONSERVATION REPORT, PORTA NOCERA NECROPOLIS, POMPEII

TOMB PXXIV 13

OCTOBER 2023

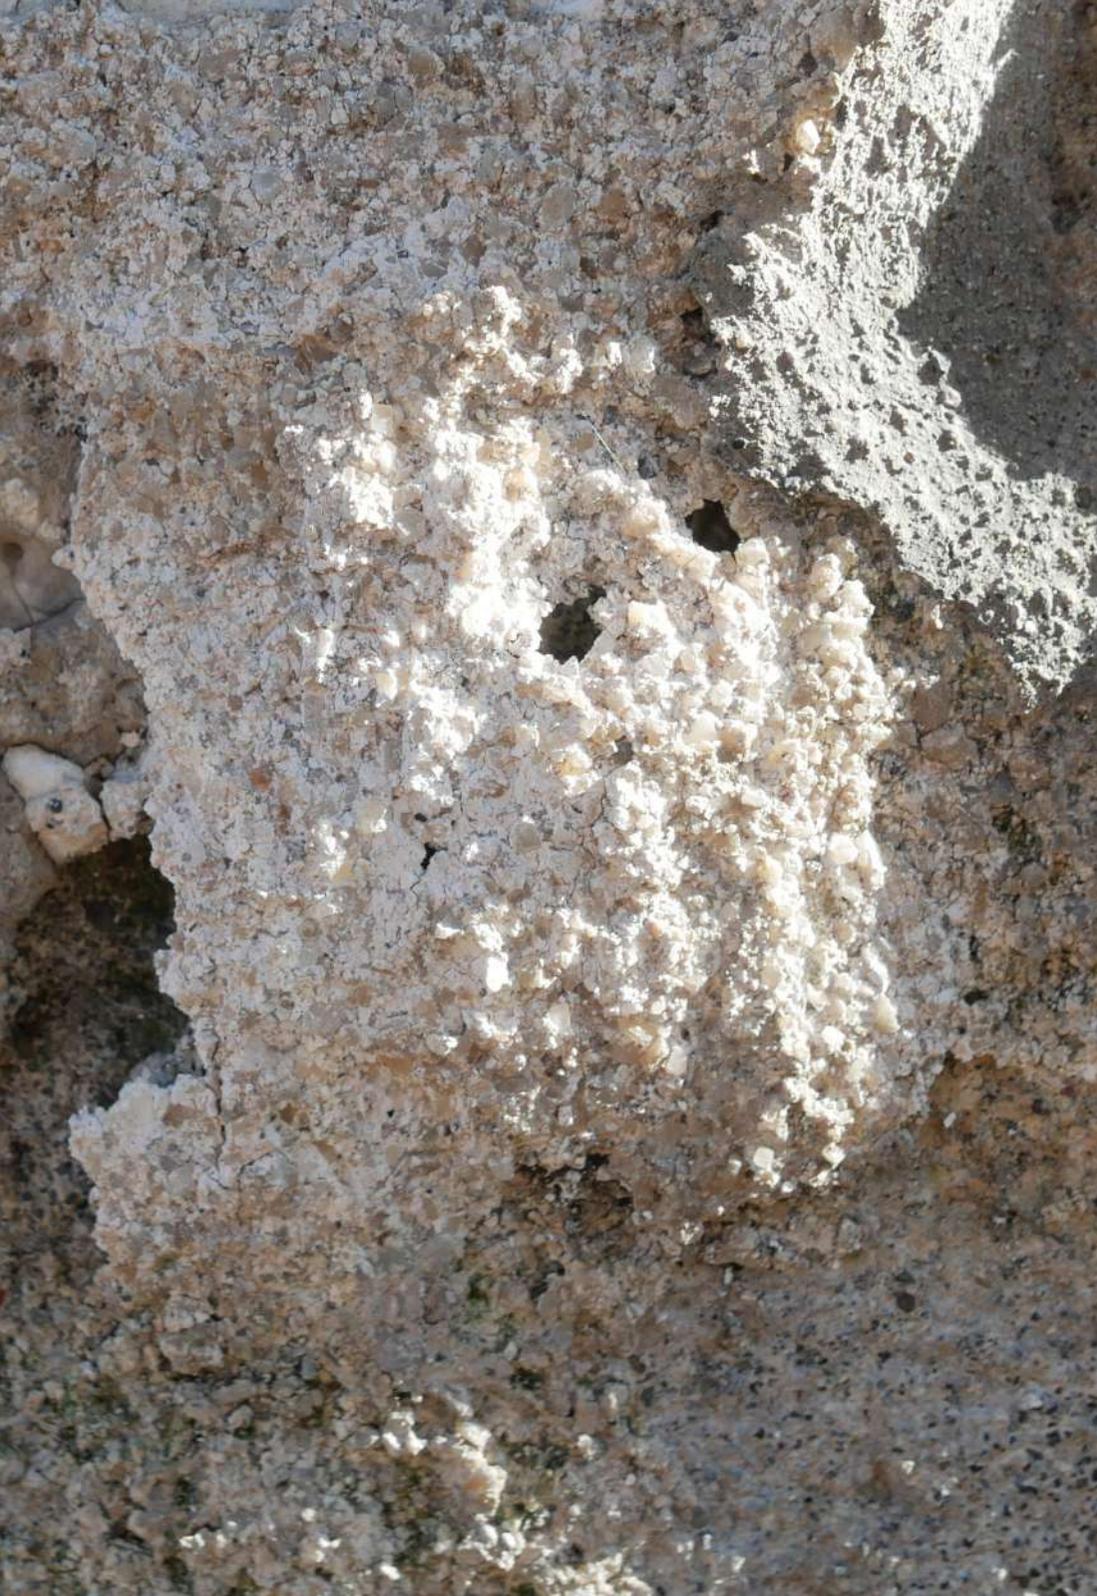
Deformation

Deformation is associated with detachment and delamination, as it refers to the existence of a void between layers, however is specifically detachment or delamination that results in bulging or movement of the plaster out of plane.

Cracks

Cracks in the plaster are visible as open cracks (affecting multiple plaster layers together where space between the crack is clearly visible) or hairline cracks (small cracks that affect one plaster layer)

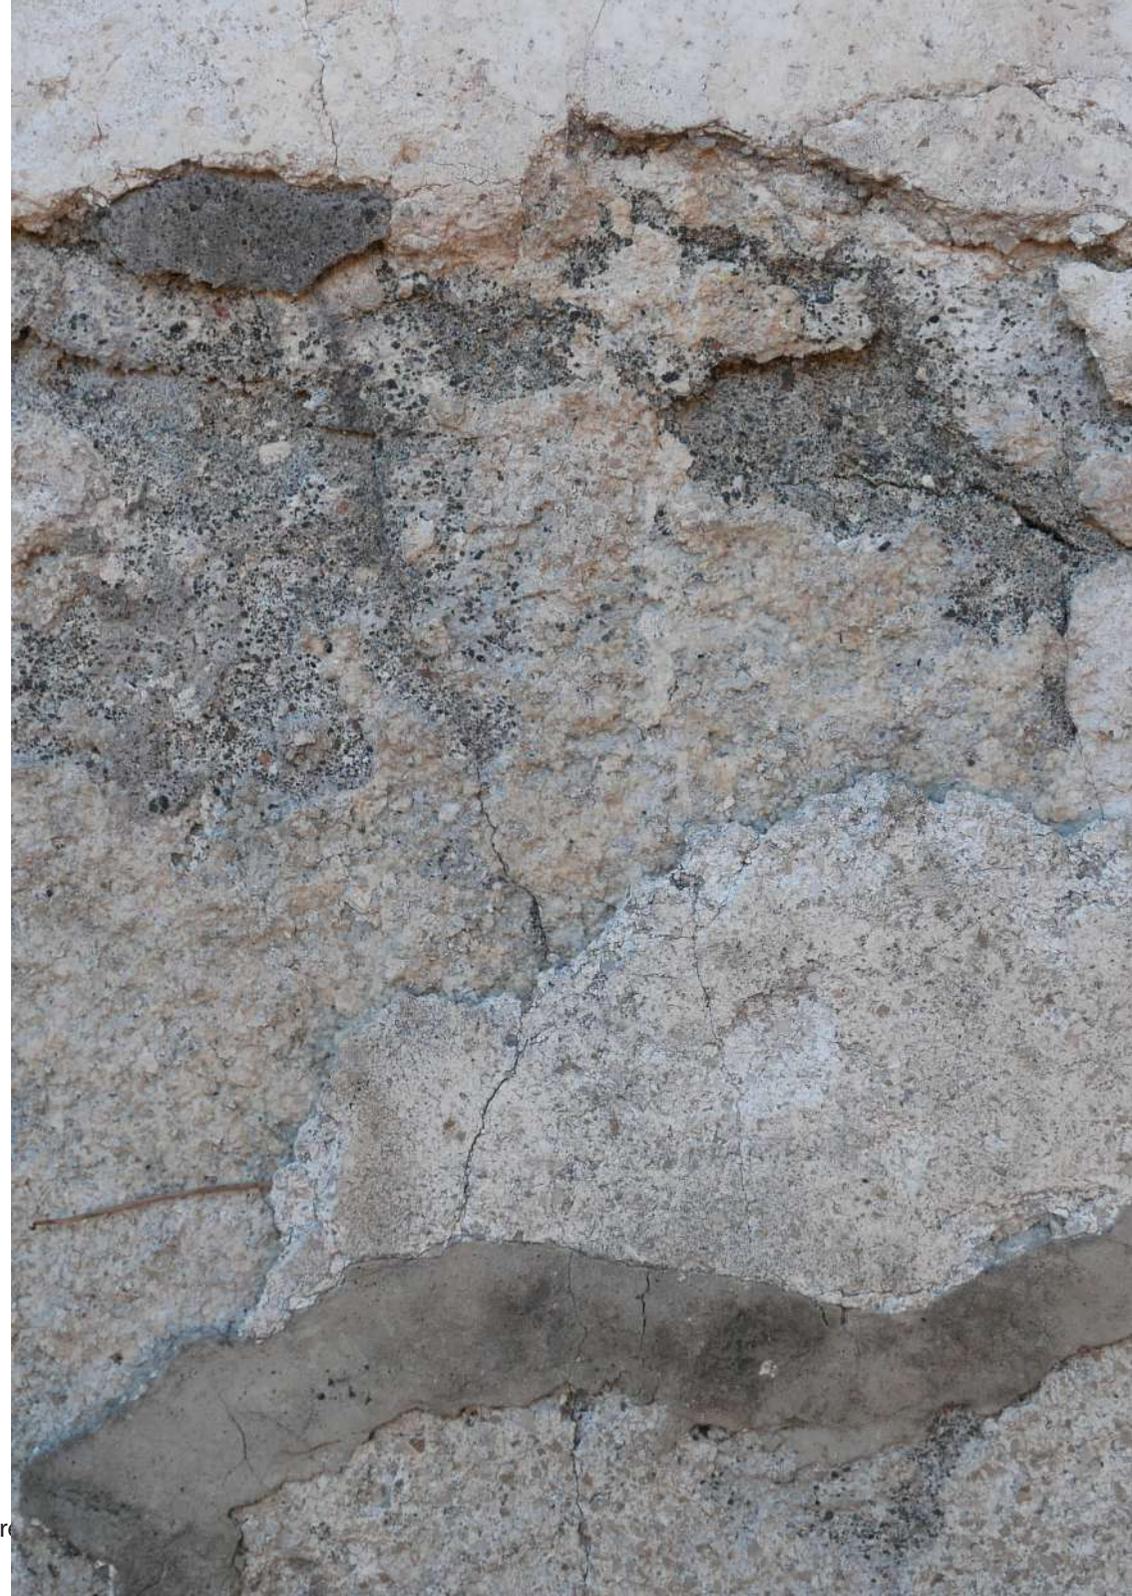
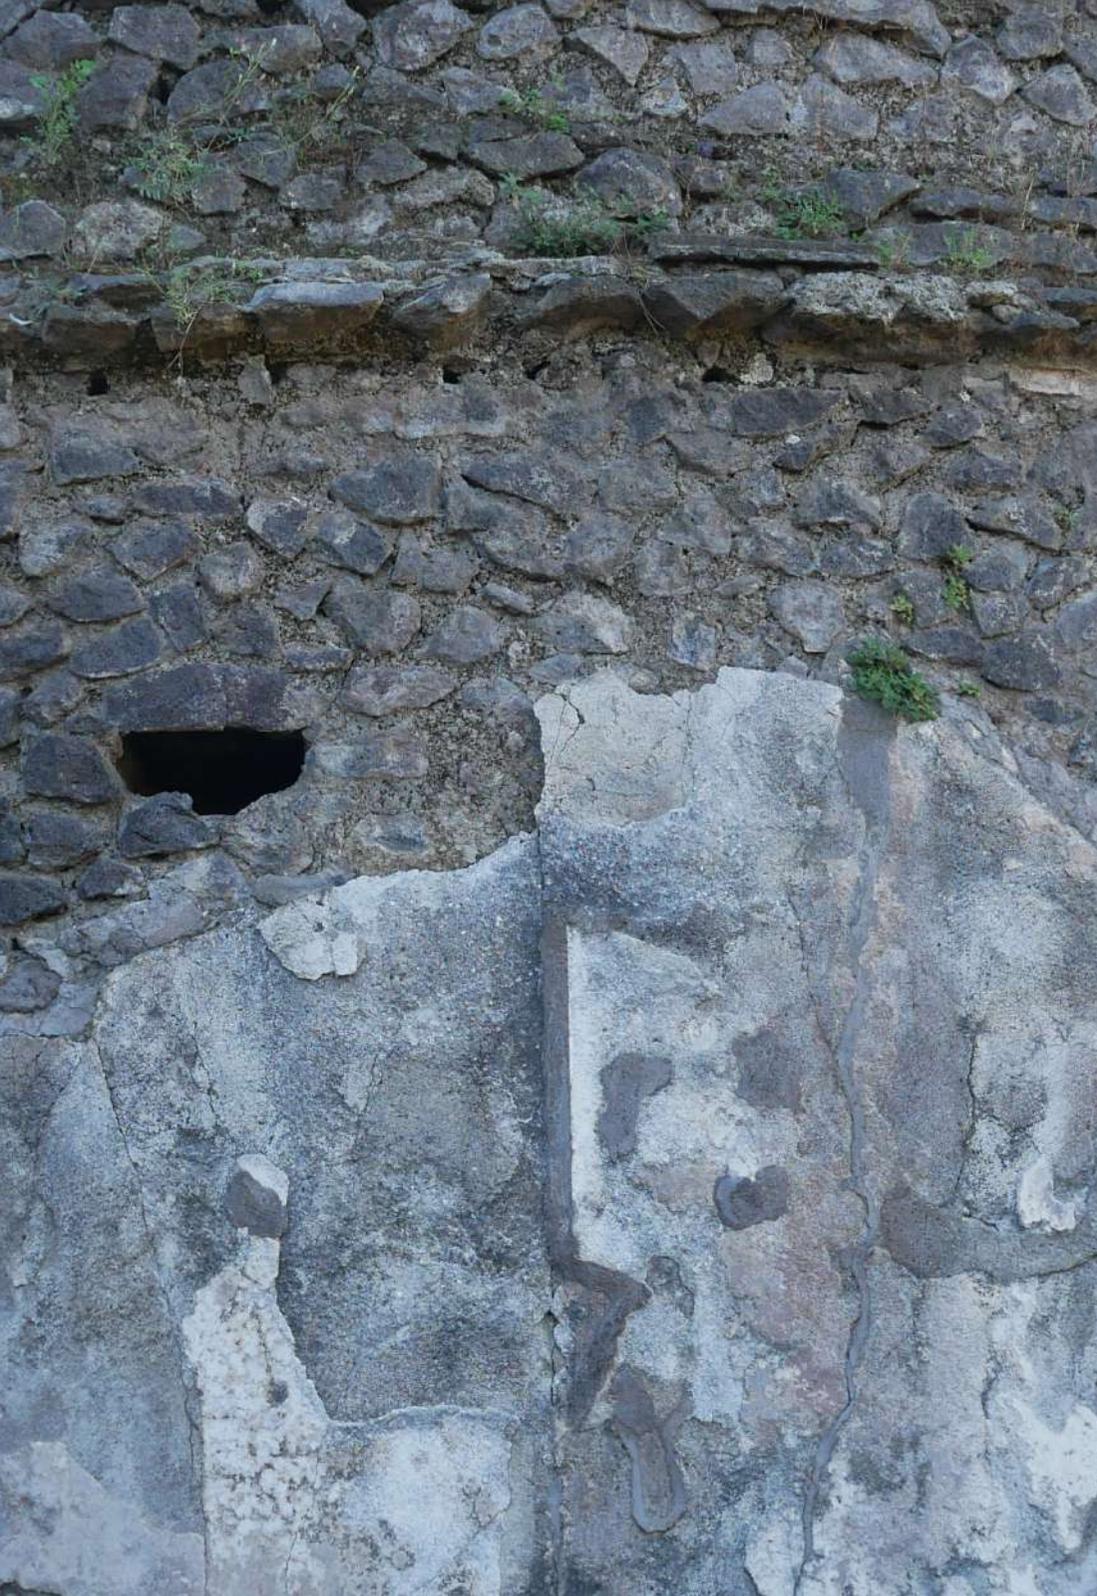
Decohesion refers to powdering, crumbling, and general loss of cohesion of a plaster layer, resulting in delocalisation of the aggregate from the binder.

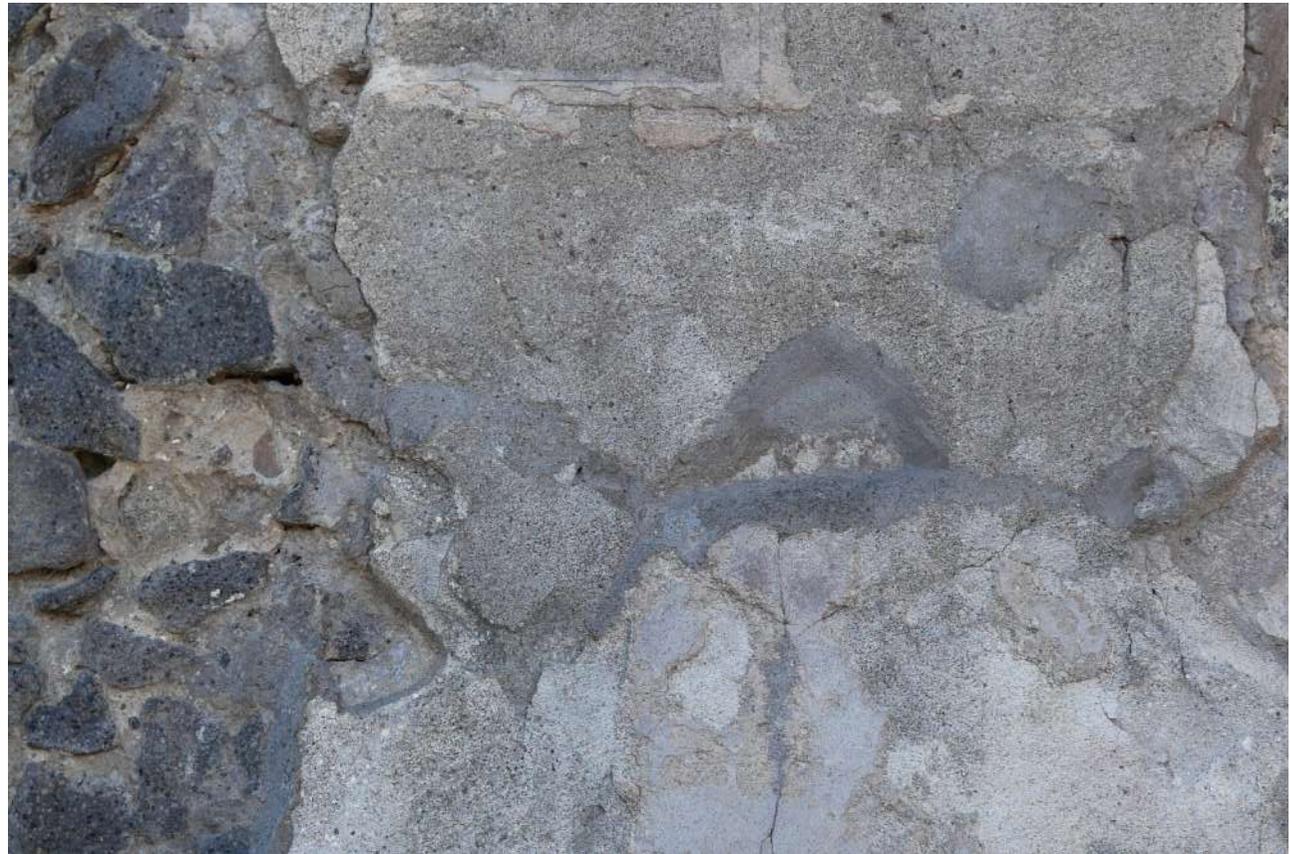
Macrobiological activity refers to the growth of plants on various structures within the archaeological site. Over the centuries, Pompeii has experienced the natural colonization of vegetation, including plant growth on architectural elements, walls, and other surfaces.

Various repair materials have been employed across the Necropolis to address issues such as cracks, losses, and damaged edges. These repairs likely took place at different points in time, possibly spanning various periods since the initial excavation.

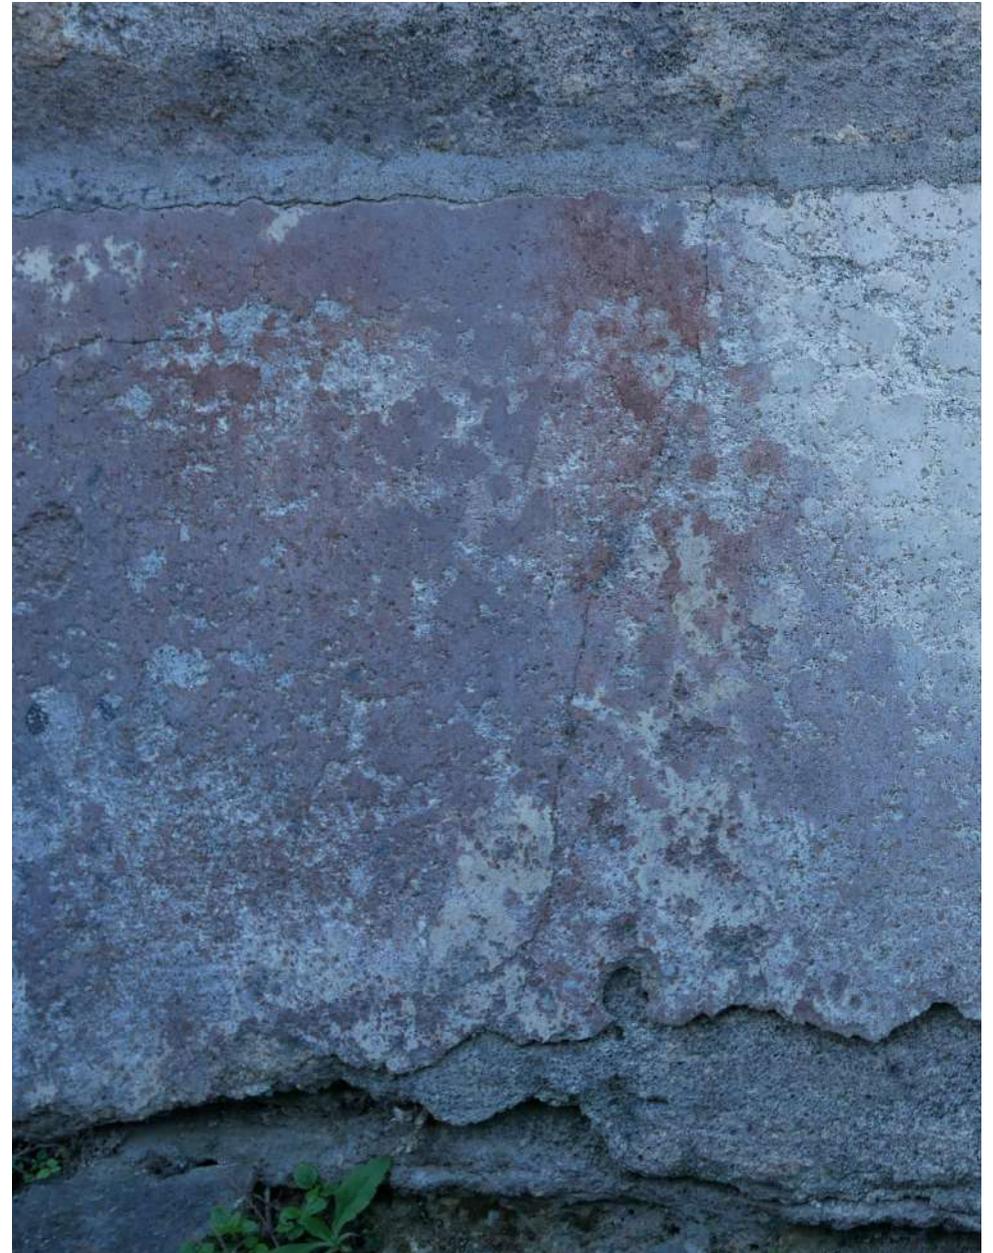
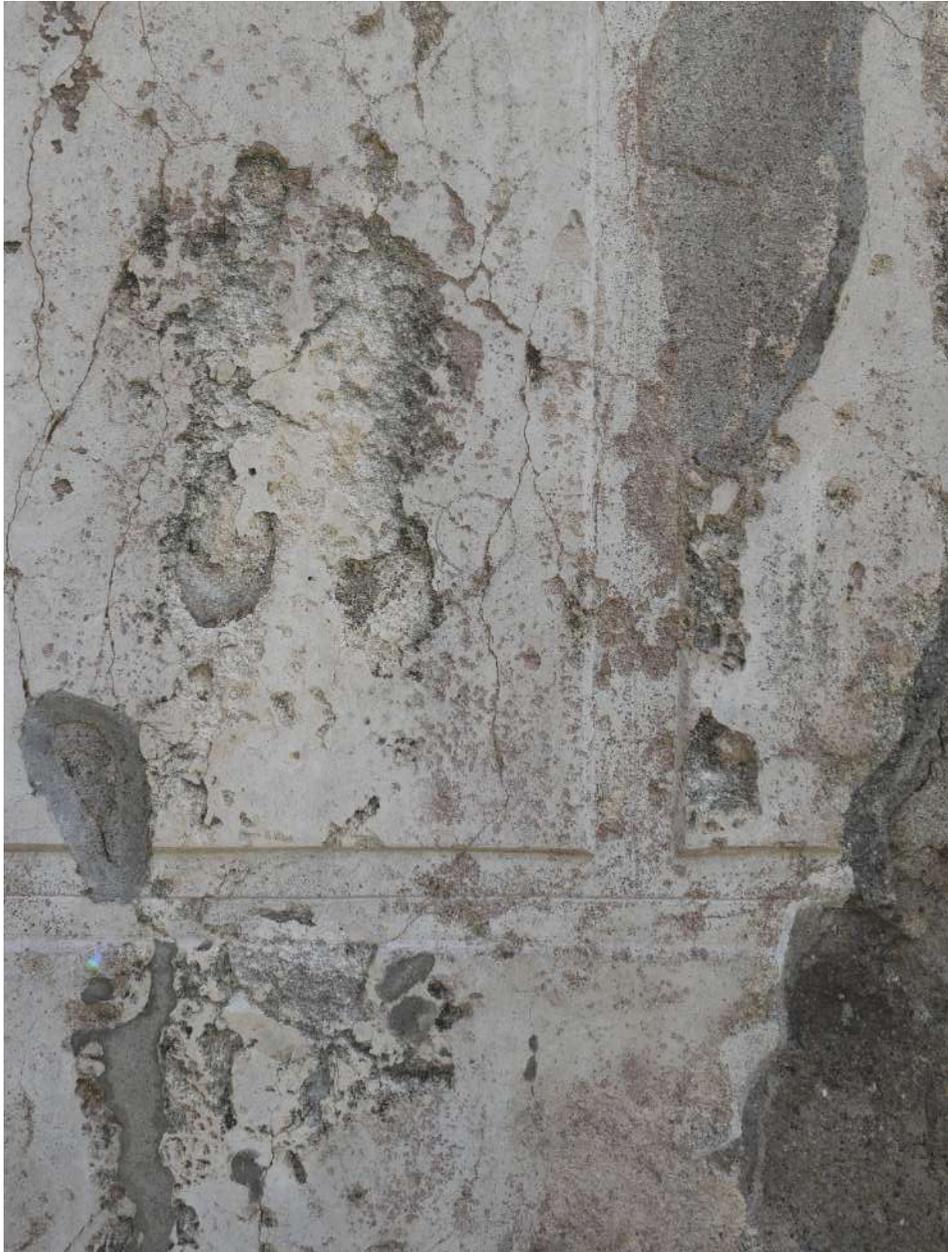
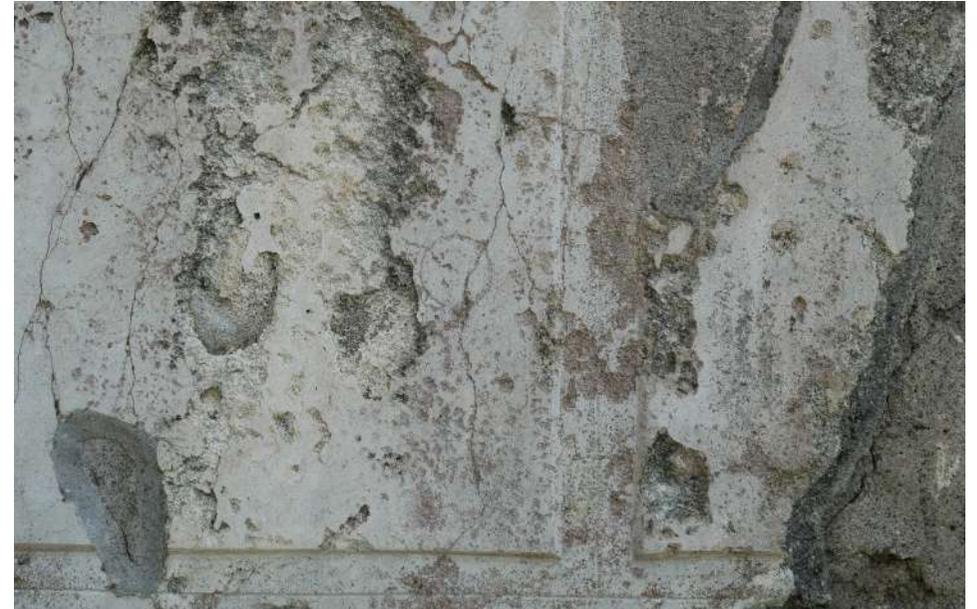
A reddish-pink substance, a type of microbiological growth, has infested numerous surfaces of the tomb. This growth is evident on sections of intonacco and stucco. The occurrence of this growth is expected, considering the tomb's exposure to the elements. It is evident that rainfall plays a role in promoting this microbiological growth, particularly observed in areas of plaster that are partially sheltered. The presence of similar growth is also noted on Tomb XXIV 24.

The presence of reddish-pink substance, a type of microbiological growth is also noted on Tomb XXIV 24.

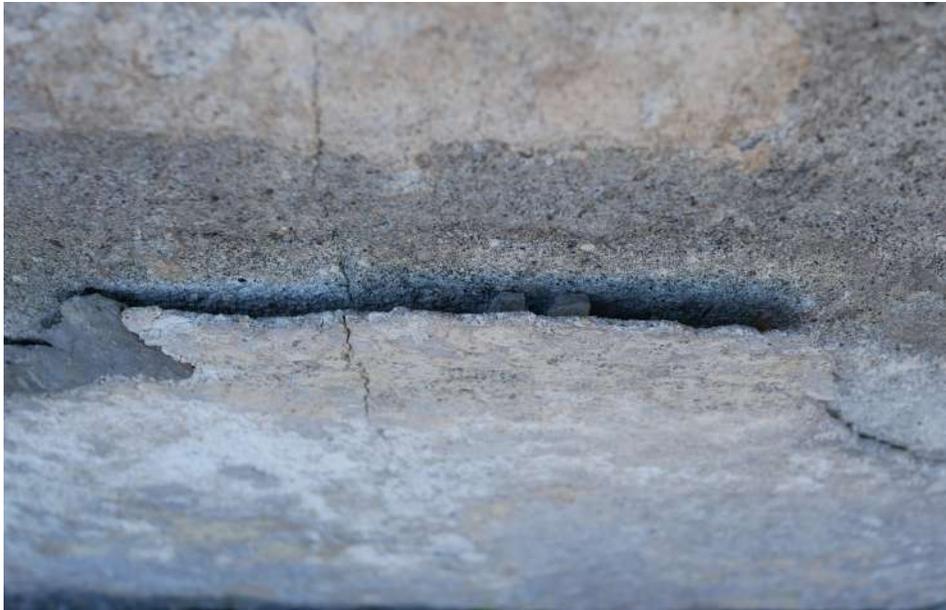
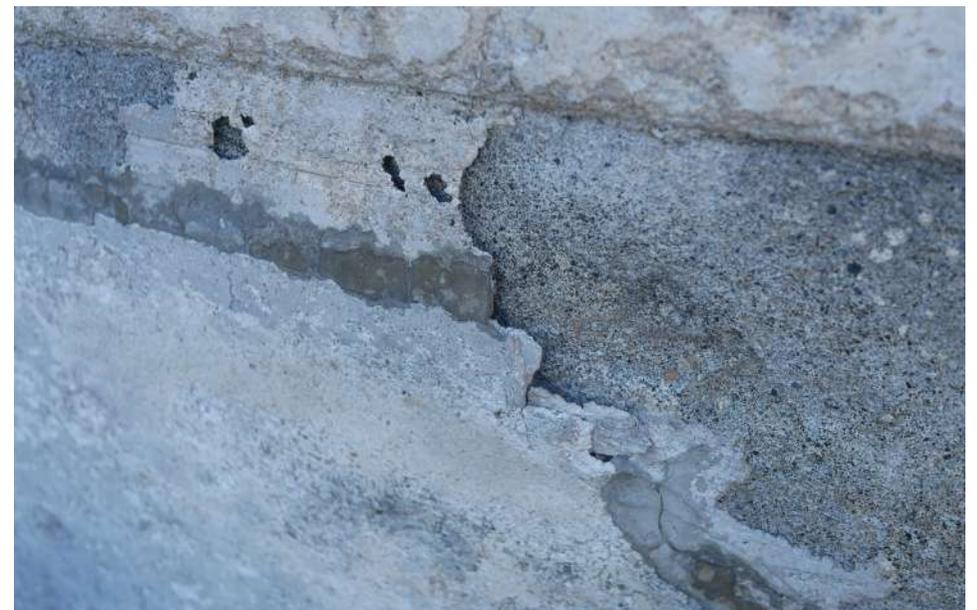
Condition: dust and dirt accumulation

The walls, exposed to the elements, have accumulated layers of dust on their surfaces, and the gaps between the loosened plaster layers have become filled with dirt. Furthermore, these walls have become host to the growth of plant vegetation. The combined impact of exposure to weathering, accumulation of dust, and the infiltration of dirt in the interstices has contributed to the degradation of the wall surfaces.

The initial step involved the delicate removal of superficial dirt using a soft brush. Subsequently, with a thorough assessment confirming the stability of the plaster layer, a puffer was utilized to systematically dislodge and remove any loose debris lingering on the surface and within the detached layers. This approach not only addressed surface grime but also prioritized the preservation of the plaster's stability, ensuring a comprehensive removal of any residual loose particles and contributing to the overall enhancement of its structural integrity.

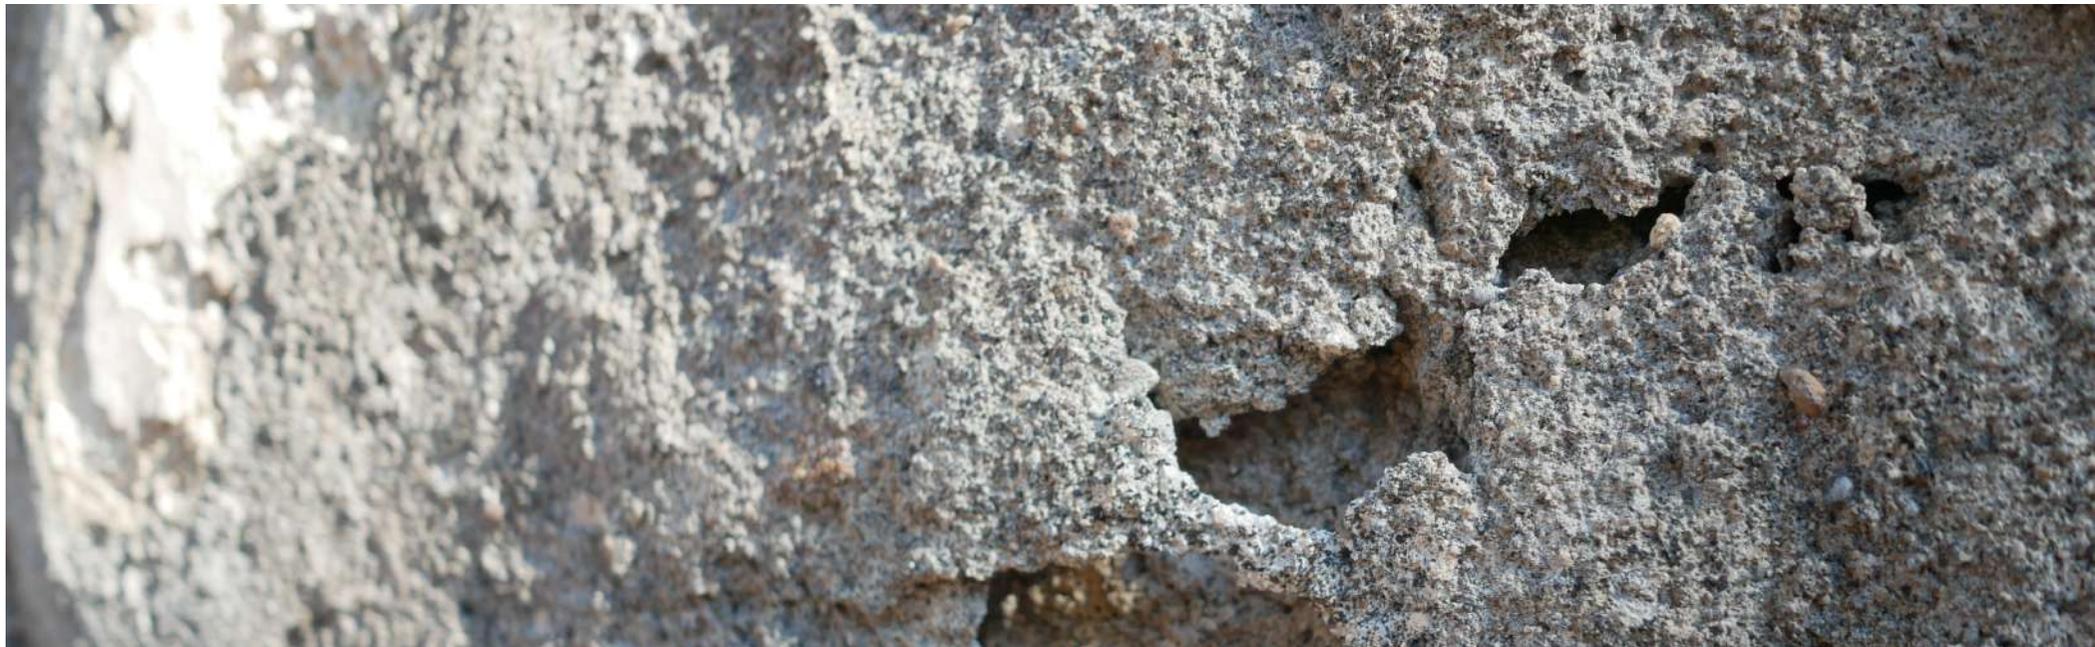
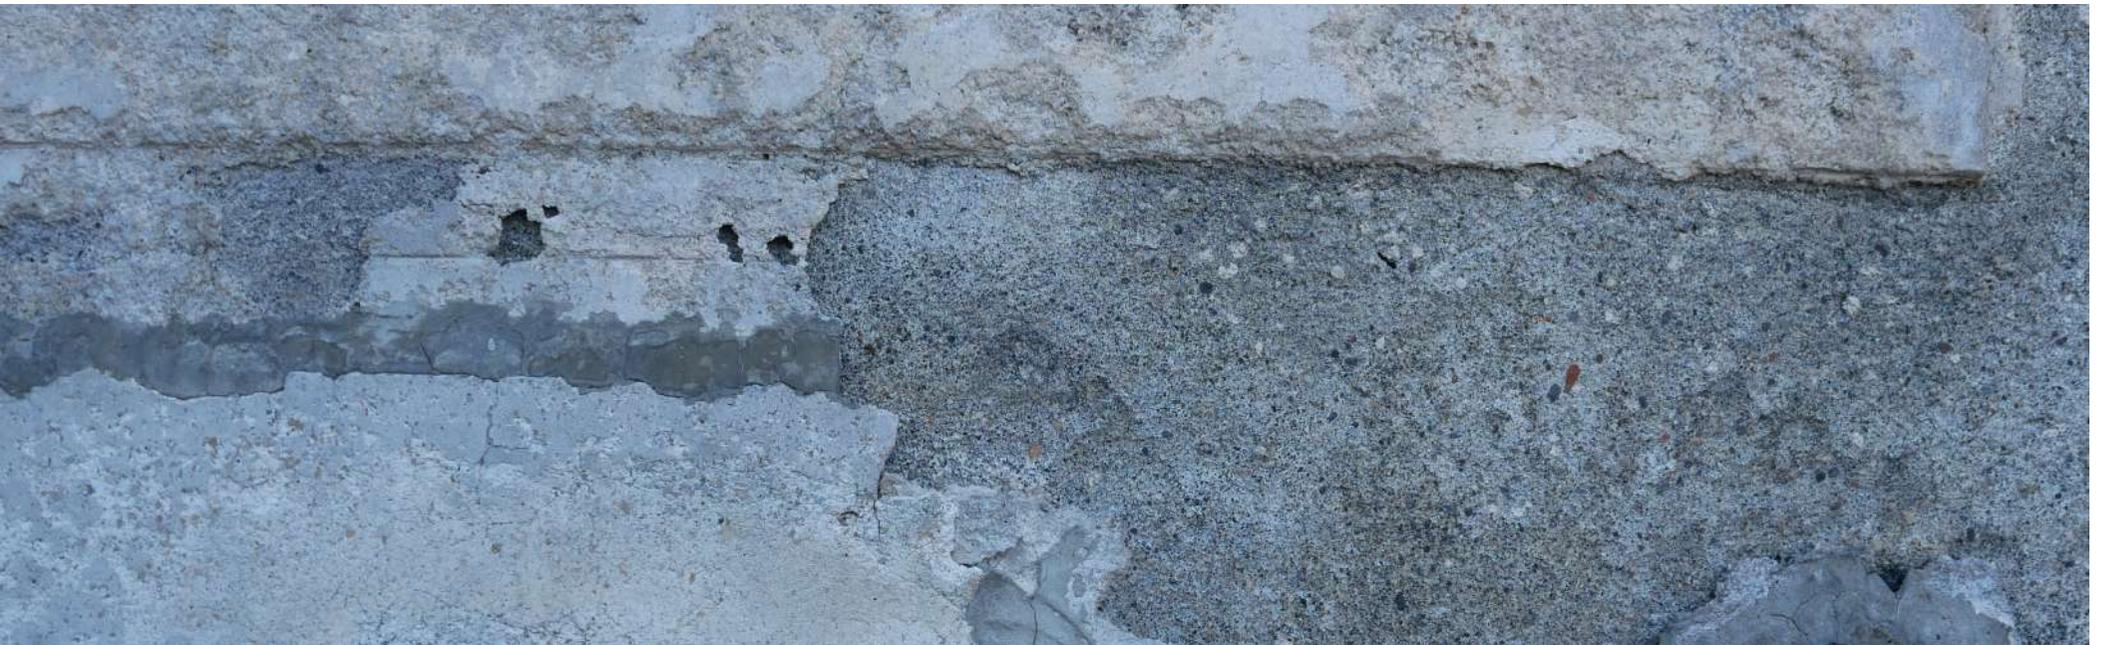
Condition: plaster decohesion

The breakdown of internal cohesion within plaster layers results in a fragile material that is susceptible to loss. The separation of plaster layers, known as plaster decohesion, can be linked to the presence of salt efflorescence and/or elevated ion content within these plaster layers. The compromised integrity of the plaster, exacerbated by these factors, contributes to its friability and increases the likelihood of material loss. Addressing these issues is vital for preserving the structural stability and aesthetic qualities of the plaster surfaces.

Calosil E 25 was considered due to compatibility with the original lime-based technology and in order to avoid solubilization and mobilization of salt-forming ions within the stratigraphy. To explore its effectiveness, four different proprietary calcium hydroxide dispersions, each with varying concentrations, were subjected to trials.

In these trials, decohesive plaster fragments from the complex served as test specimens to evaluate penetration and the rate of evaporation. Additionally, sand was incorporated to assess the cohesive strength of the consolidant system.

The trial results revealed that Calosil E 25 exhibited the most favorable penetration without resulting in surface accumulation, a phenomenon often associated with lower evaporation rates. The optimal application methodology involved multiple applications using a pipette or syringe, coupled with the mitigation of evaporation by covering treated areas. These findings underscore the potential of Calosil E 25 as a suitable consolidant, offering insights into its application to address specific challenges within the conservation context.

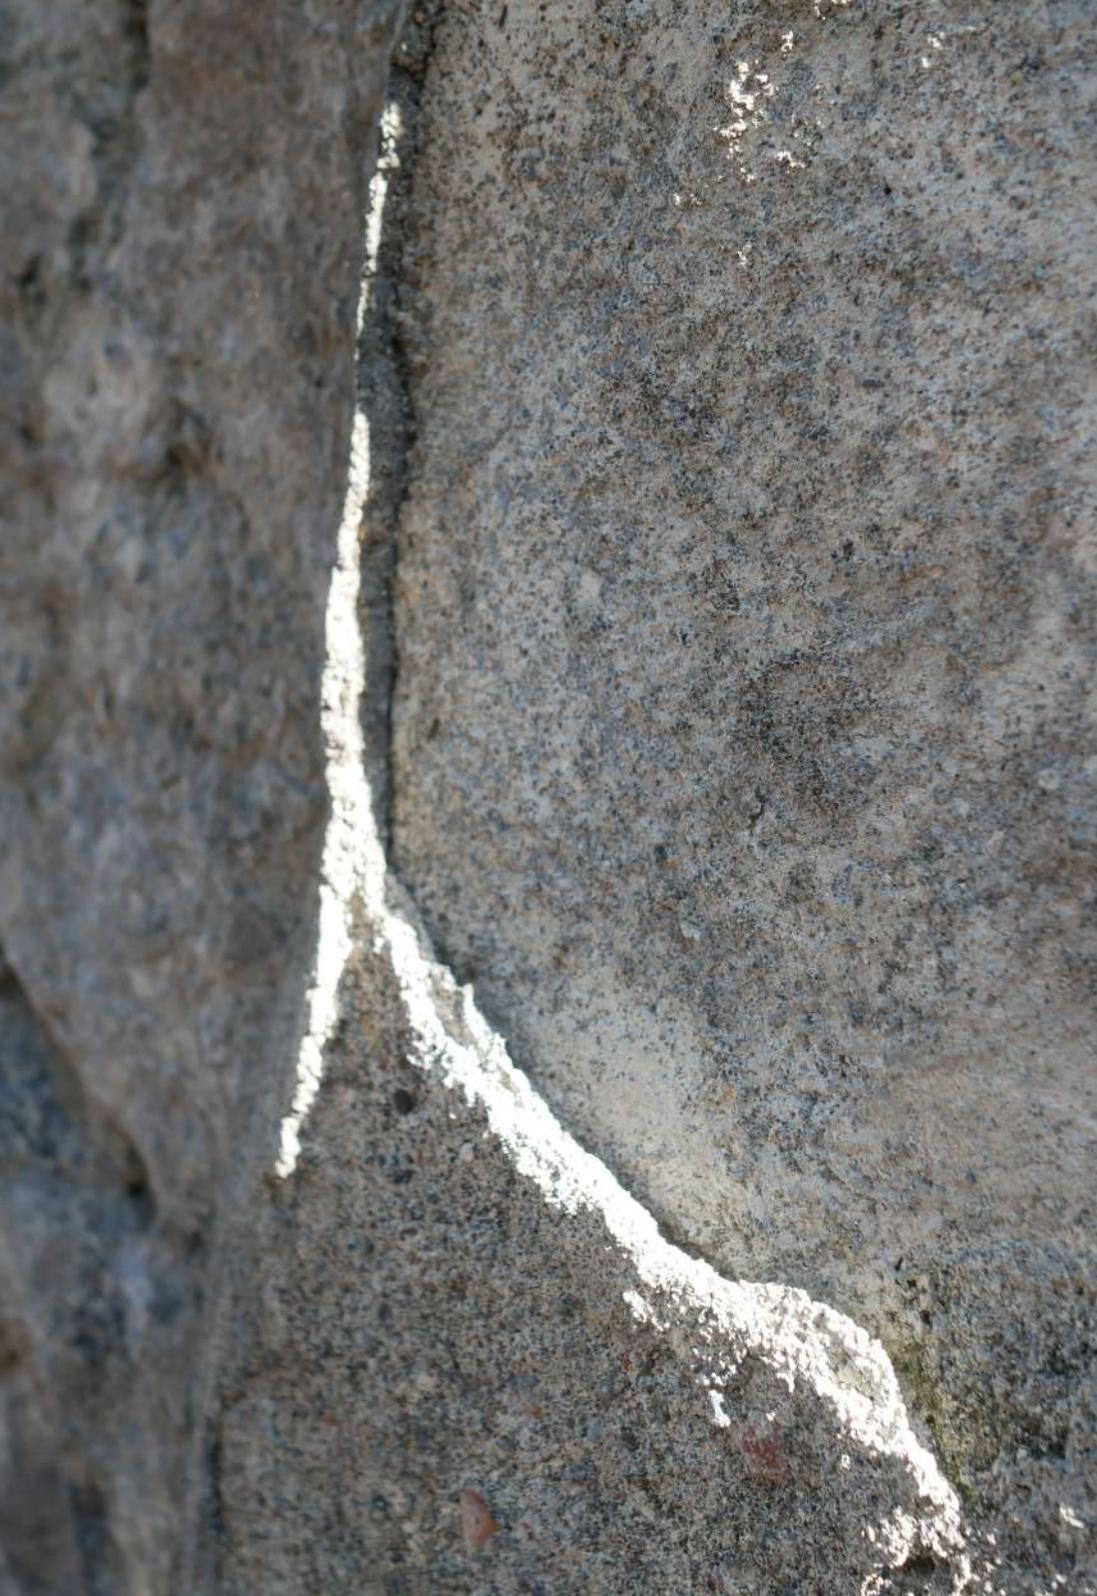
Plaster consolidation

Condition: exposed edges of the plaster layer

The exposed edges of the plaster layer present a notable concern in the current state of the archaeological site. The condition is characterized by sections where the protective layer of plaster has worn away or eroded, leaving the underlying structure vulnerable to environmental elements. These exposed edges are susceptible to further degradation, including potential damage from weathering, microbial growth, and other environmental factors.

In addressing the restoration of exposed edges, our approach is rooted in the selection of materials and proven application methods. The edge repairs were executed using materials that underwent thorough testing in the past, demonstrating both compatibility with the existing structure and their efficacy in similar conservation scenarios.

Preservation efforts include the application of consolidants, edge repairs, and grouting in some cases, to fortify the plaster layer and mitigate the risk of ongoing deterioration. Effectively addressing the condition of exposed edges is crucial for the long-term conservation of the site, ensuring the safeguarding of its historical and cultural value.

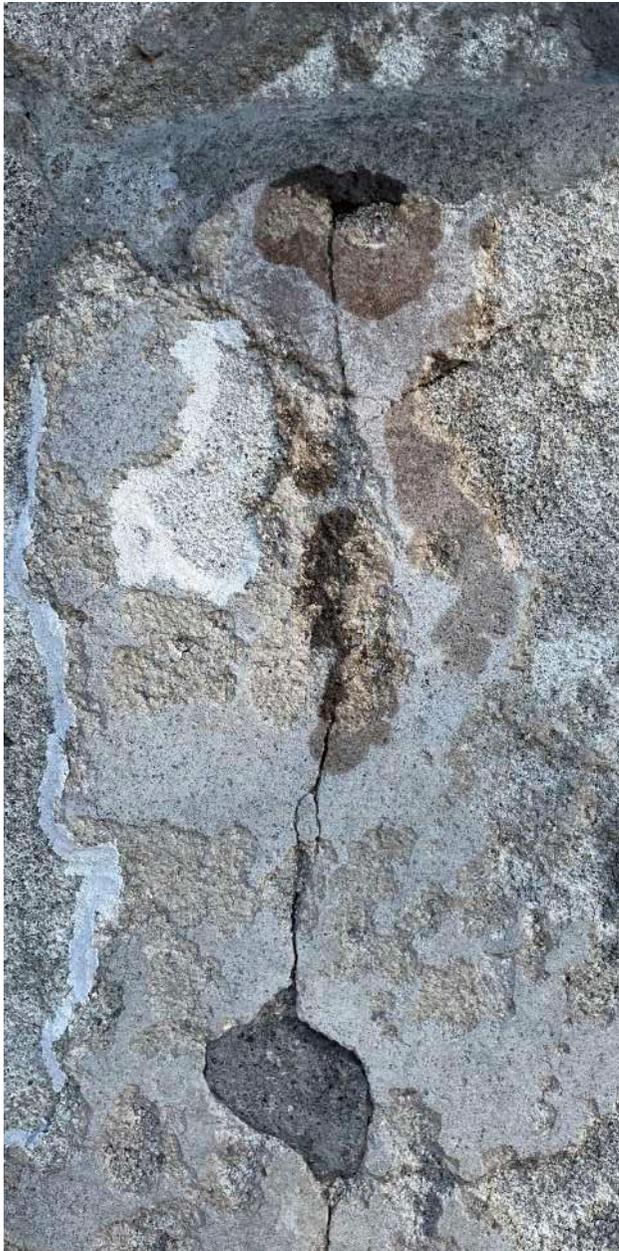
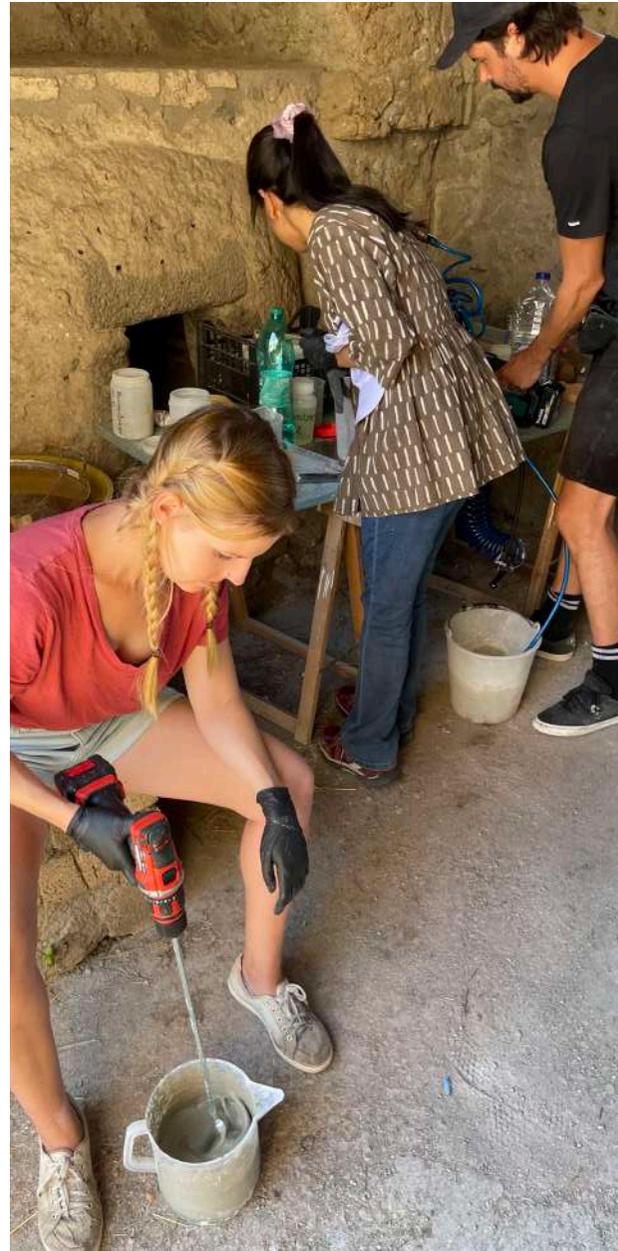
Condition: delamination

The observed condition of delamination manifests across a spectrum, encompassing a diverse range of areas within the studied context. Delamination is identified as the separation or detachment of layers, and in this instance, it occurs at various locations within the plaster stratigraphy.

The treatment for delamination involved the grouting process utilizing a specialized foam mortar. The targeted application of this foam mortar proved instrumental in addressing and rectifying delamination issues within the affected structure.

For delamination with narrow access and of smaller nature, a micro grout was prepared using the same material mixture, albeit with finer particles. This micro grout, designed to penetrate even the minutest spaces, complemented the overall grouting strategy, ensuring a comprehensive and thorough treatment for delamination.
